2007/2008 Annual Monitoring Report

Arroyo De La Laguna
Alameda County, California

U.S. Army Corps of Engineers File Number: 30262S
California Department of Fish and Game Notification Number: 0600-2006-0272-3
Regional Water Quality Control Board Site No.: 02-01-C0903

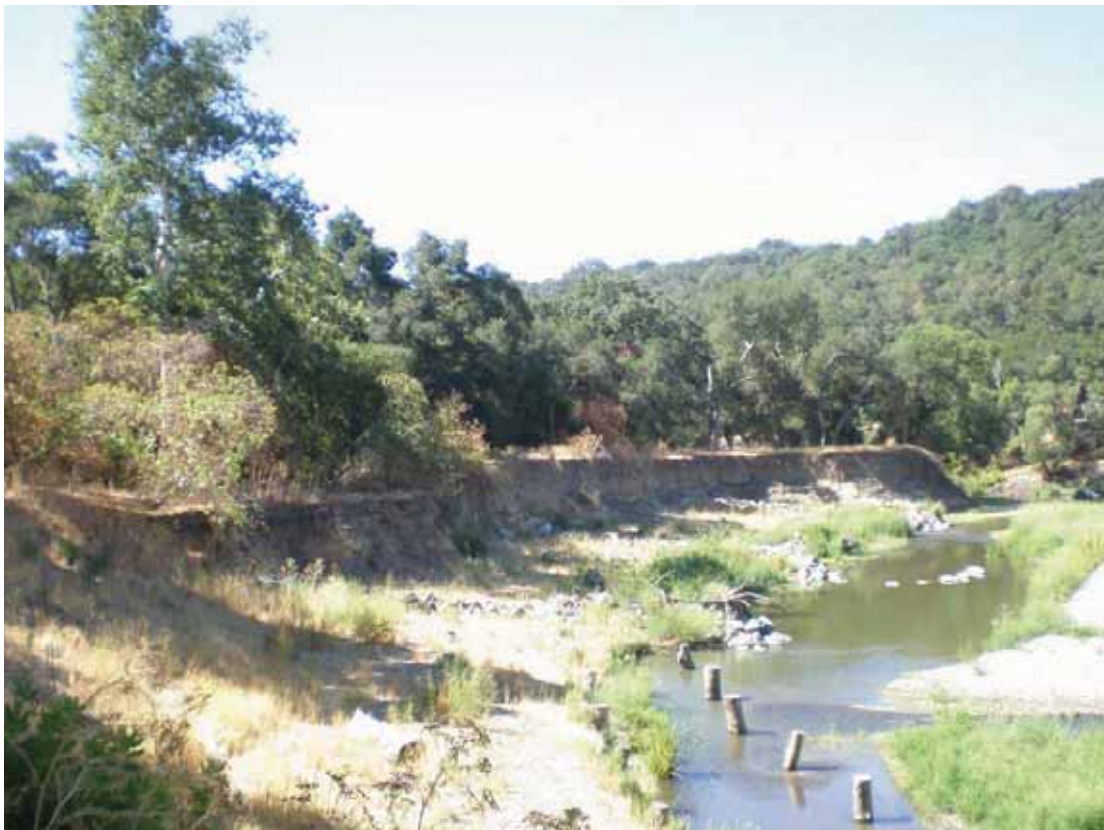
August 2008 Photo Monitoring Point 3

No headcuts or nick points are visible in the channel reach. No evidence of significant incision or aggradation of the channel bed was seen. Some erosion of the terrace toe occurred between Rock Barb 2 and Rock Barb 3 but the erosion has not impacted the bank (see Photo Monitoring Point 3 photo). This erosion occurred during the first winter after construction (2006/07) and did not worsen during the 2007/08 winter, even following the major storm event January 7, 2008.

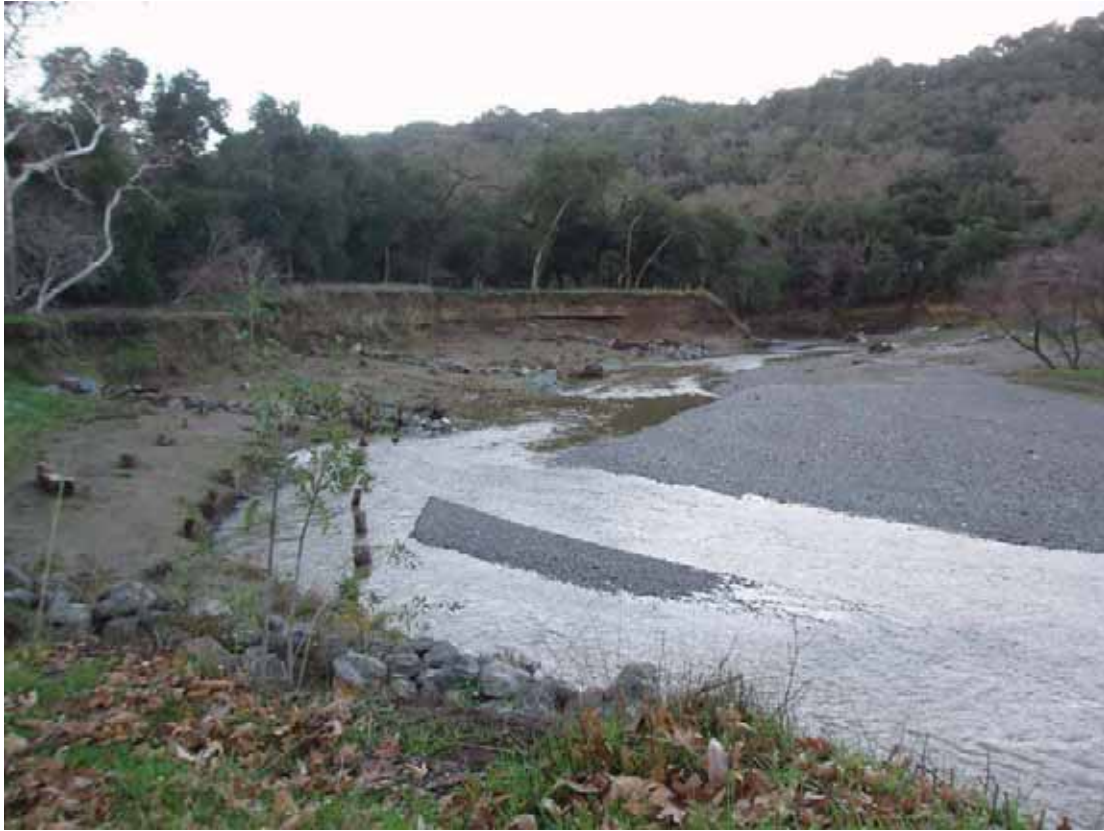
Overall the stream channel through the reach of the project appeared geomorphically stable during the monitoring period. According to USGS Stream Gauge data collected near the project site, the peak flow during this monitoring period was 7,090 cfs, from a storm on January 7, 2008 (see photo). The channel forming, bankfull flow is estimated to be 3,000 cfs and the 25-year design flow is estimated to be 13,000 cfs.

January 2008 - Storm Event 7,090 cubic feet per second peak flow

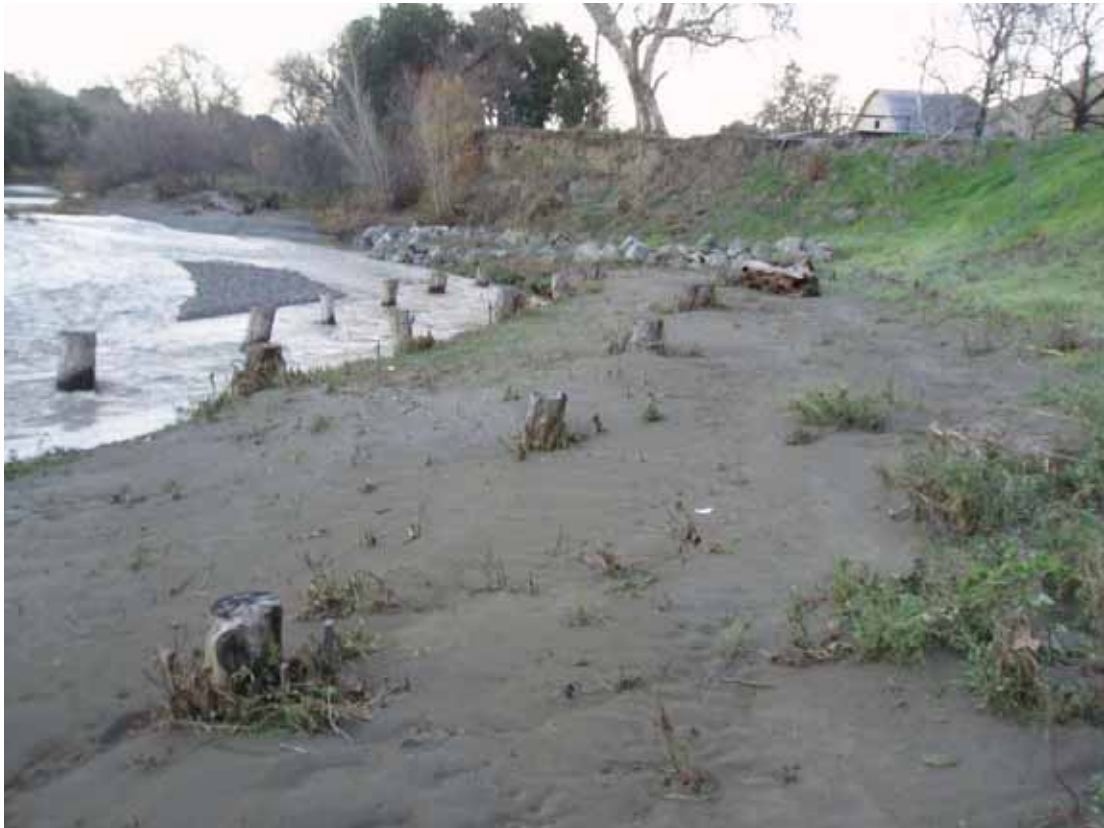
Sediment build up is evident on the constructed terraces between rock barbs (this is desirable for the project) and on the inside stream curves.

January 2008 – Post Storm Event Deposition on Terrace

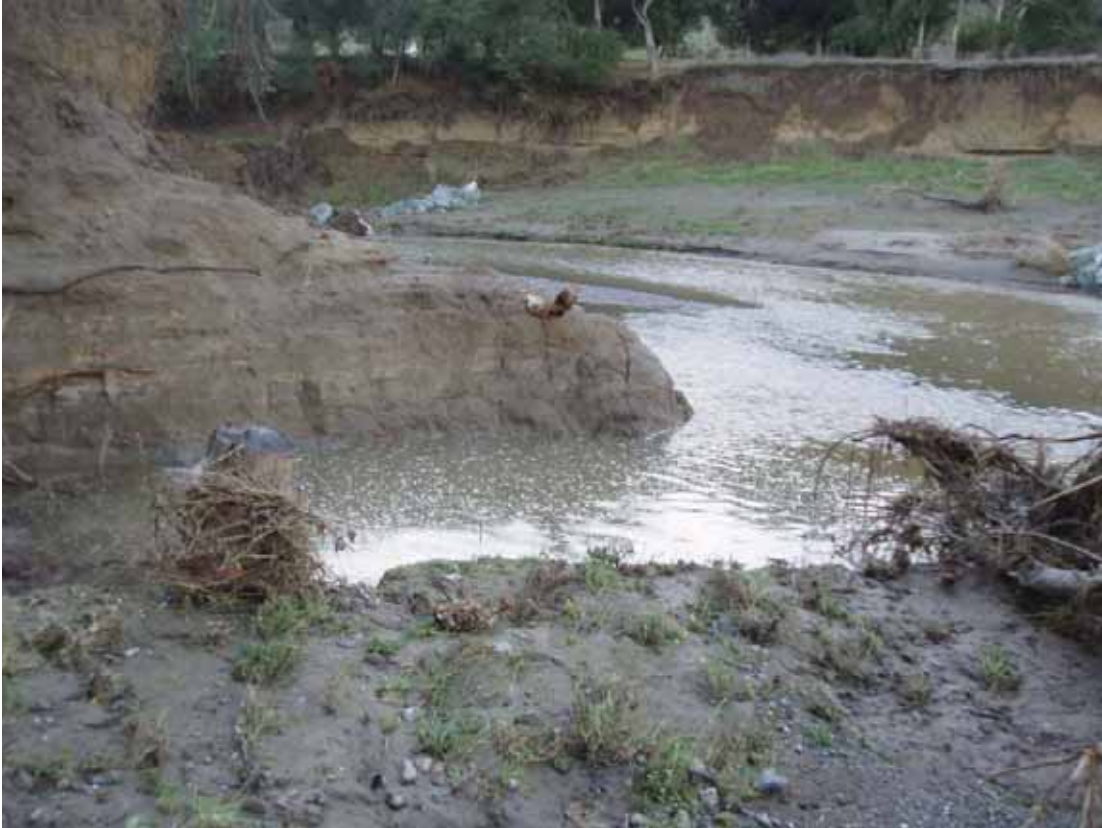
continued to scour the terrace in this area, as described in the 2006/2007 Annual Monitoring Report. However, a depositional bar also formed in this area during lower flows (see photo). The Christmas tree revetment here, which was a temporary practice and will not be replaced, was swept away during the January 7, 2008 storm. Overall, the erosion appeared to impact less than a foot of soil on the banks and no trees on the tops of the banks were impacted.

January 2008 – Storm Event – Point and Former Christmas Tree Revetment

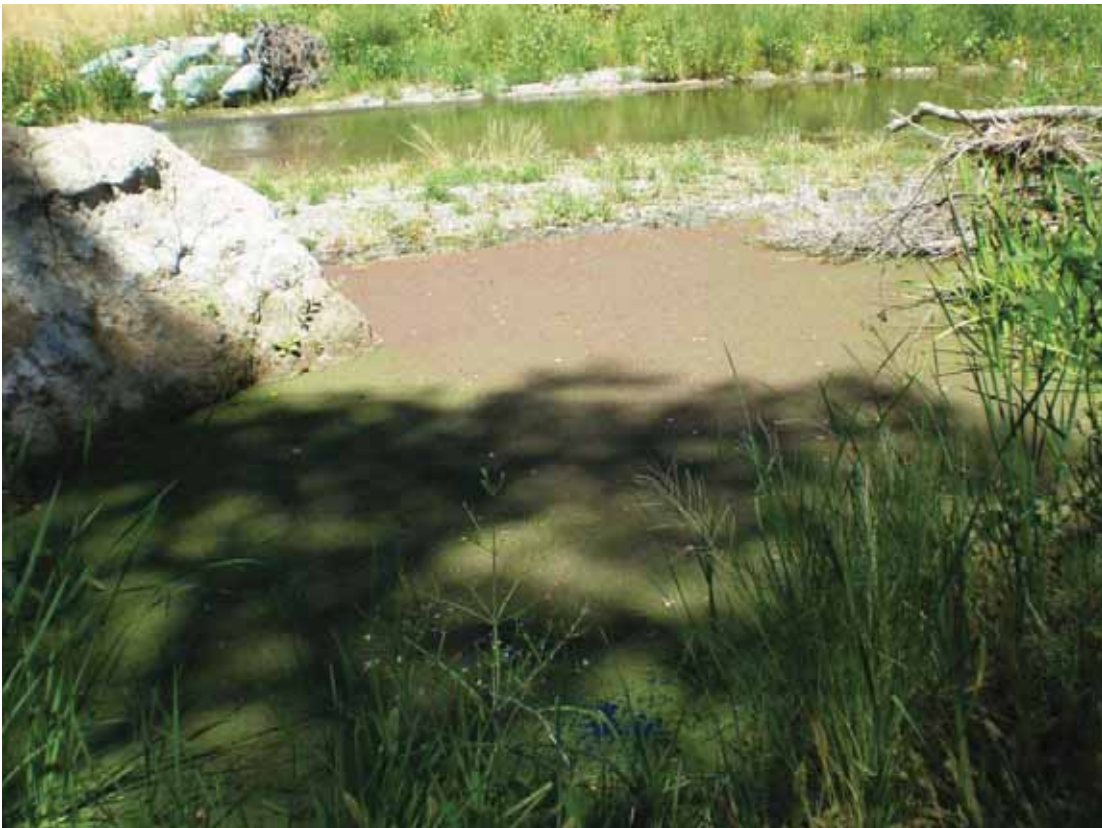
August 2008 – Inland pool formed at Barb 5 at former Christmas Tree Revetment Site

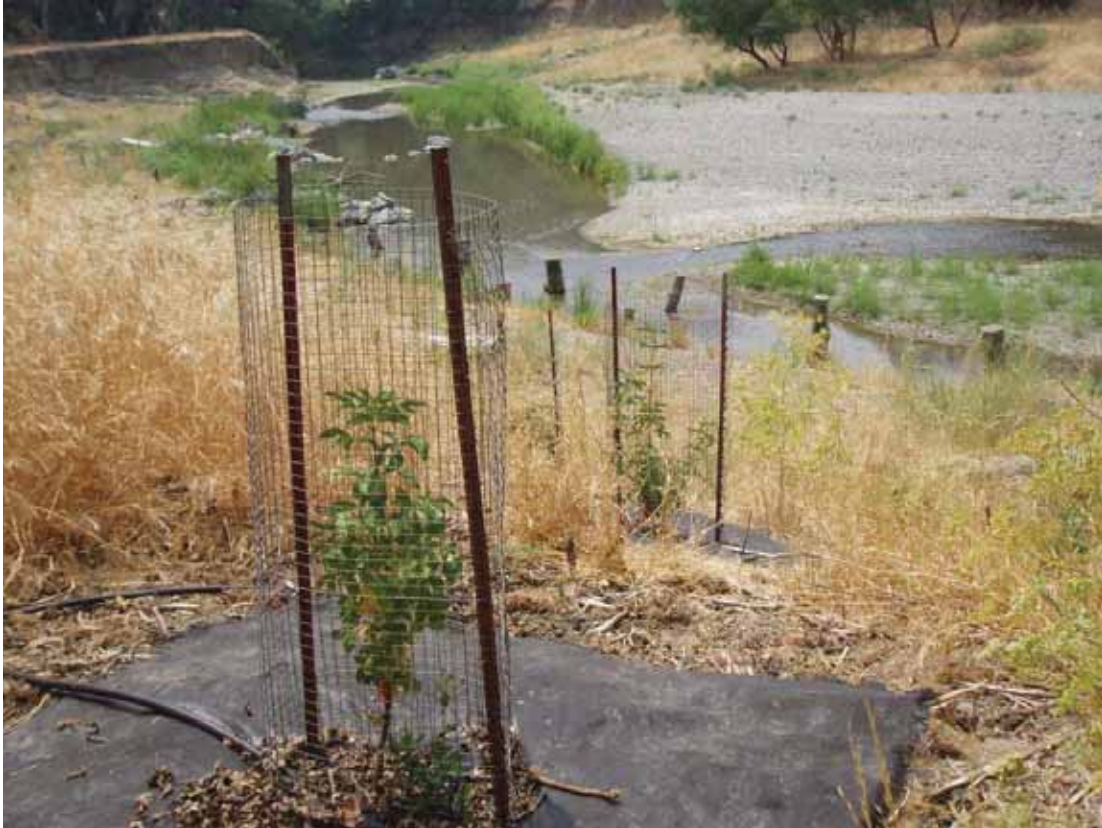
In Planting Zone 2, California buckeyes achieved 100% survival (18 trees). Buckeyes are being disrupted by rodents due to slight erosion that has allowed a gap to form between the ground and the fence. Willow stakes in Zone 2 and along the toe of the banks have not survived well in most of the project (less than 20%) as many were installed too high on the terraces to survive the drought years. New willow stakes are planned in conjunction with an irrigation system in order to establish willows in Zone 2, especially along the toe of the banks.

May 2008 - California Buckeye plantings

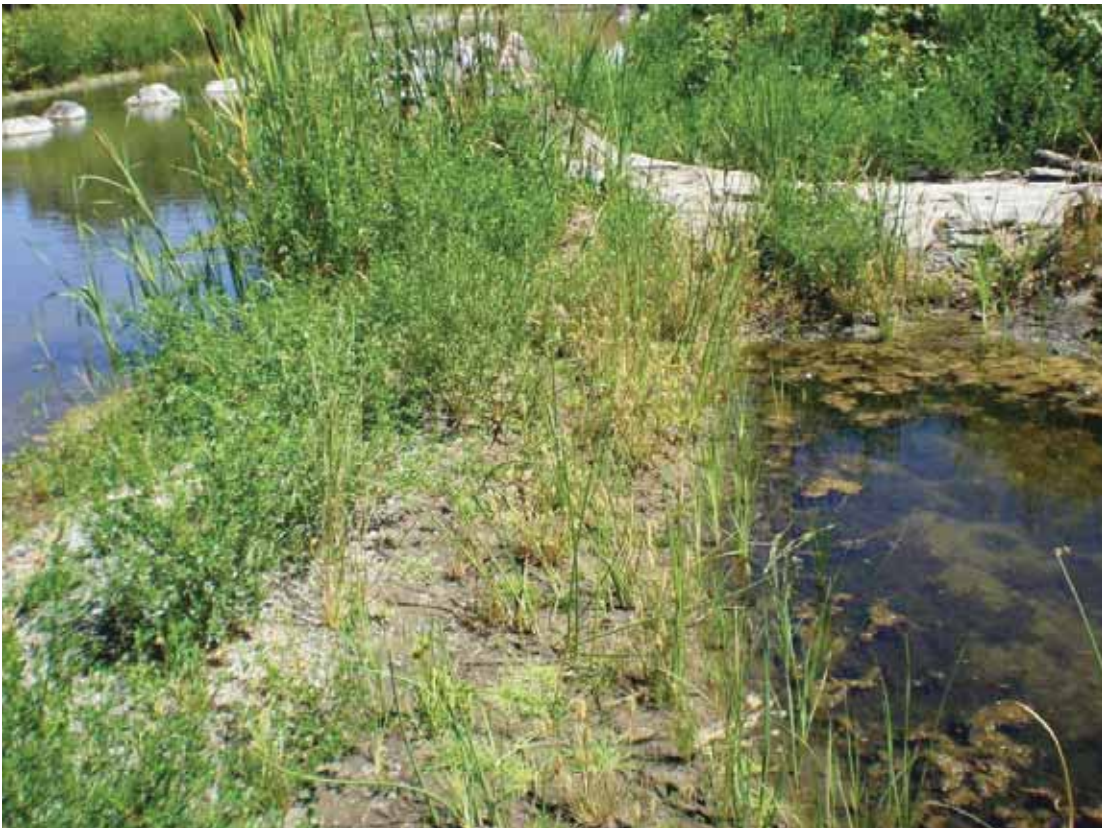
Bank erosion did occur during this monitoring period, chiefly in the form of sloughing of soil from the vertical banks near Rock Barbs 4 and 5. The sloughing occurred following the January 7, 2008 storm flows and the sloughed soil remains on the terrace where it may be stabilized by vegetation before the next large storm. The pattern of flow around the "point" of bank near Rock Barb 5

August 2008 – Deposition at Barb 4 and Inland Pool
