## **2008/2009 Annual Monitoring Report**

Arroyo De La Laguna  
Alameda County, California

U.S. Army Corps of Engineers File Number: 30262S  
California Department of Fish and Game Notification Number: 0600-2006-0272-3  
Regional Water Quality Control Board Site No.: 02-01-C0903

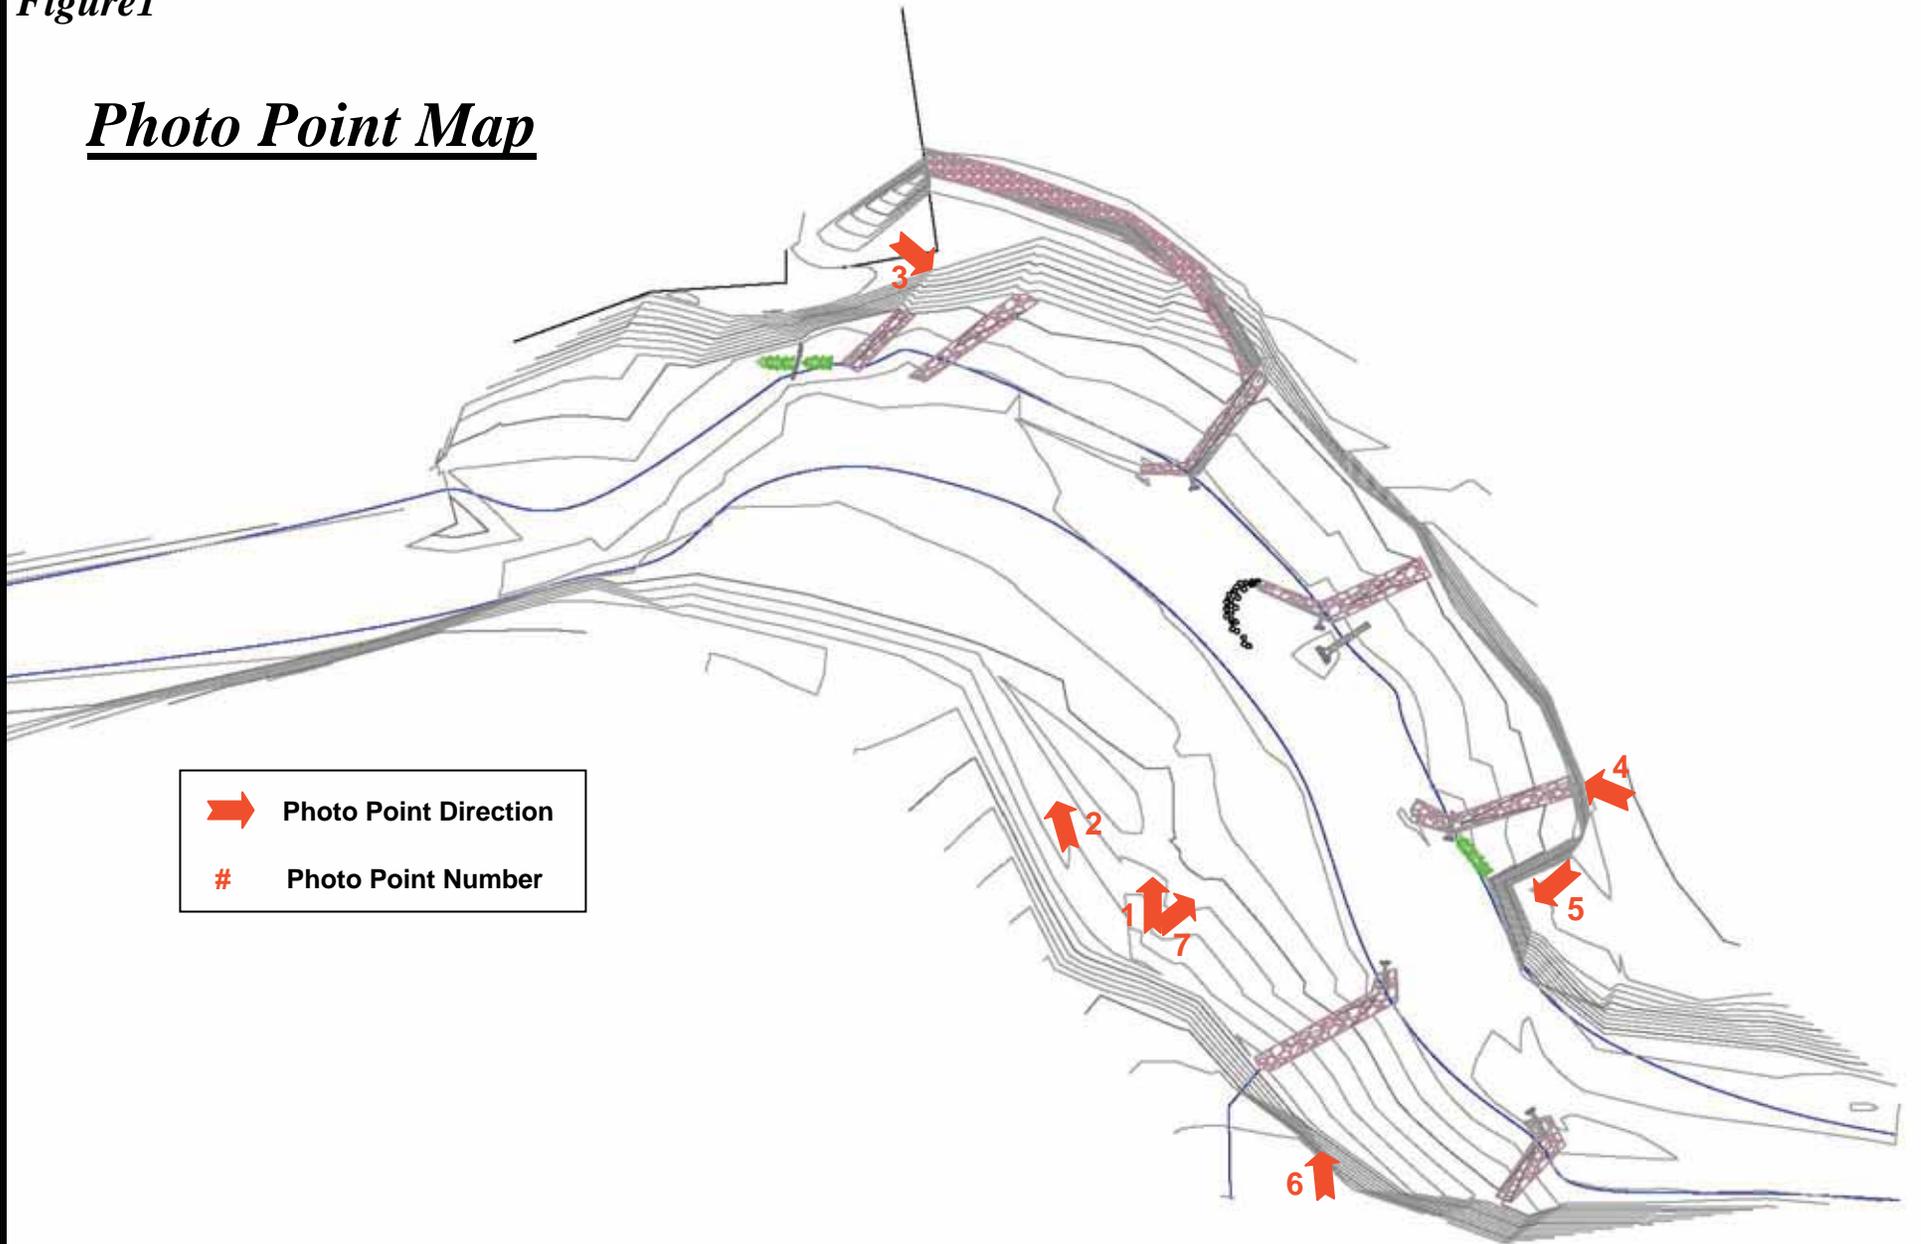
Figure 1 shows a map of the permanent photo points and directions. The photographs from this monitoring period are included in Appendix A. Each photo is labeled with location point or feature name, purpose of photo, and date. Pre-Project photographs from the photo points are also included for comparison.

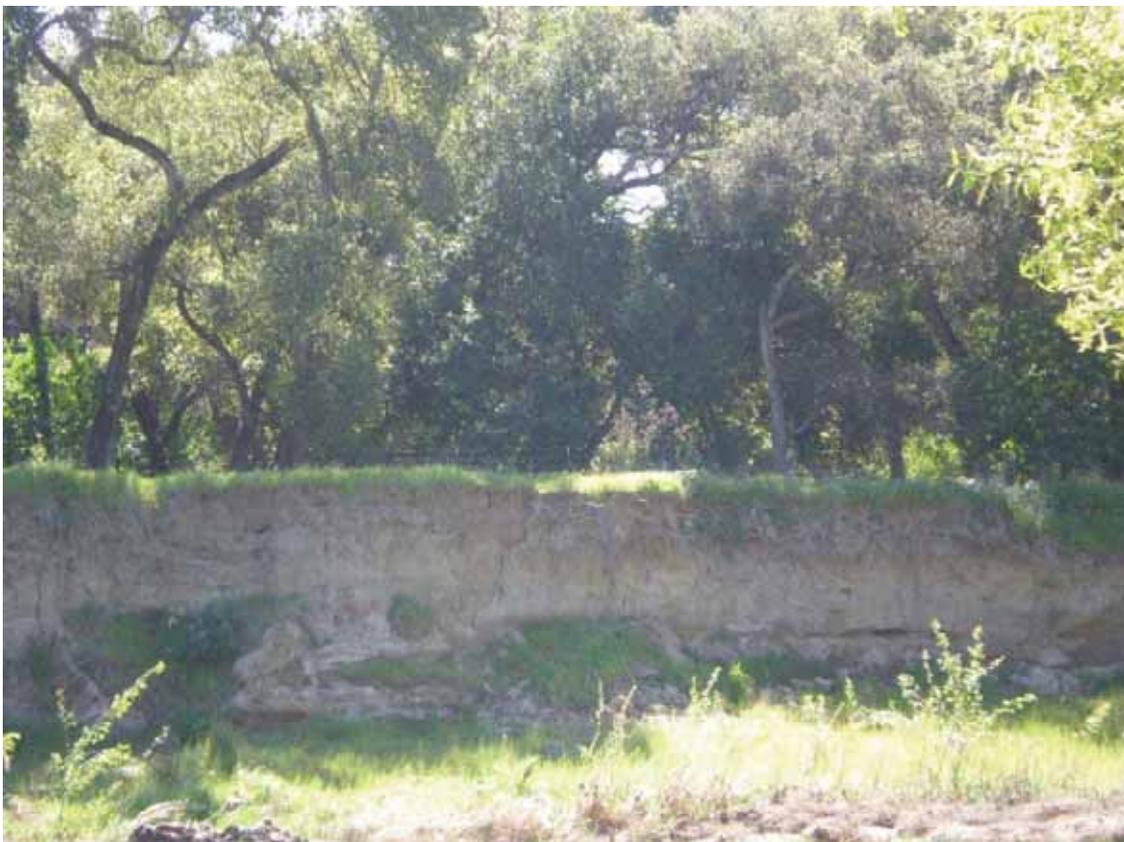
**April 2009 Photo Monitoring Point 7**

Bank erosion did not occur during this monitoring period as there were no significant flow events. Vegetation has established on the soil sloughed during the 2007/2008 (see Photo Monitoring Point 7 photo). No additional trees from the top of bank have been lost since construction.

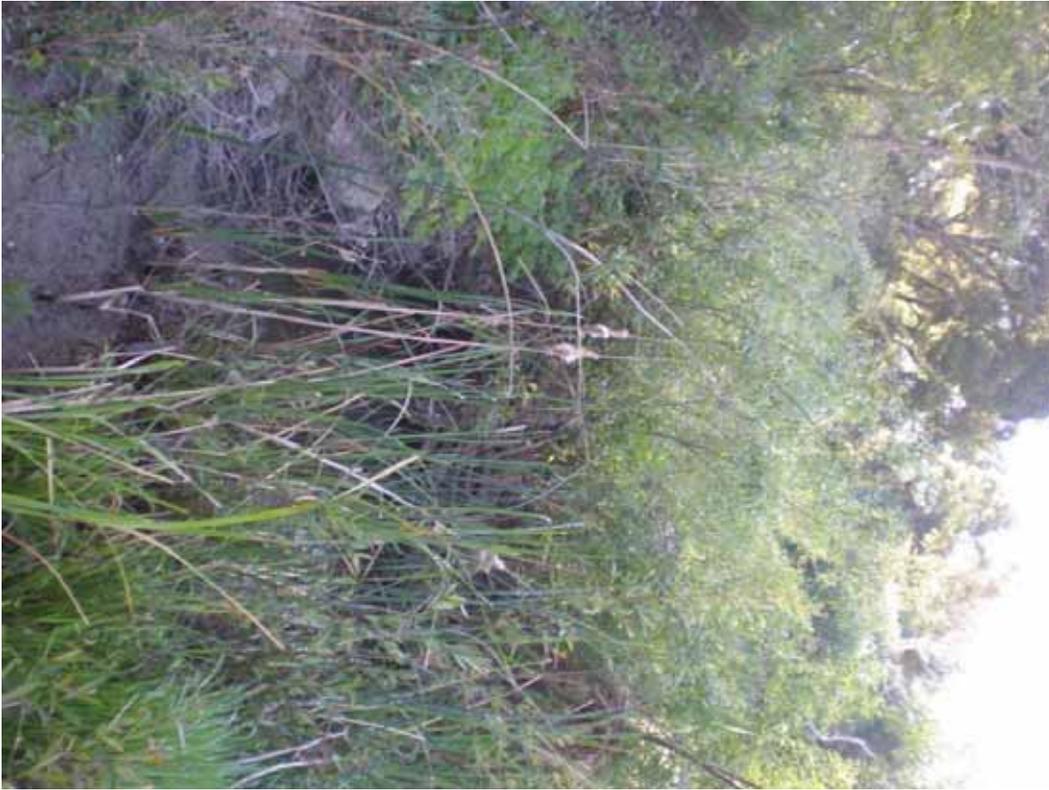
- The vegetative barb (a temporary practice) successfully performed its intended purpose. It is no longer part of the active channel and is half covered with sediment. Willows that were part of the barb have taken root and are now growing (see photo).
- Pipe Outfall near Rock Barb 6 – erosion below pipe unseated some of the rocks in the rock barb in 2007. The situation has improved over previous years as vegetation establishes and stabilizes the erosion (see photo). Rock barb will still function as designed.
- Sediment deposition around some of the rock barbs has isolated some of the rootwads from the stream during low flows (see photo). Otherwise the sediment deposition is desirable and aquatic plants have already established along the toe of the terraces to provide cover, food and other habitat functions.

**April 2009 – Willow growth, sediment deposition and vegetation establishment at vegetative barb**

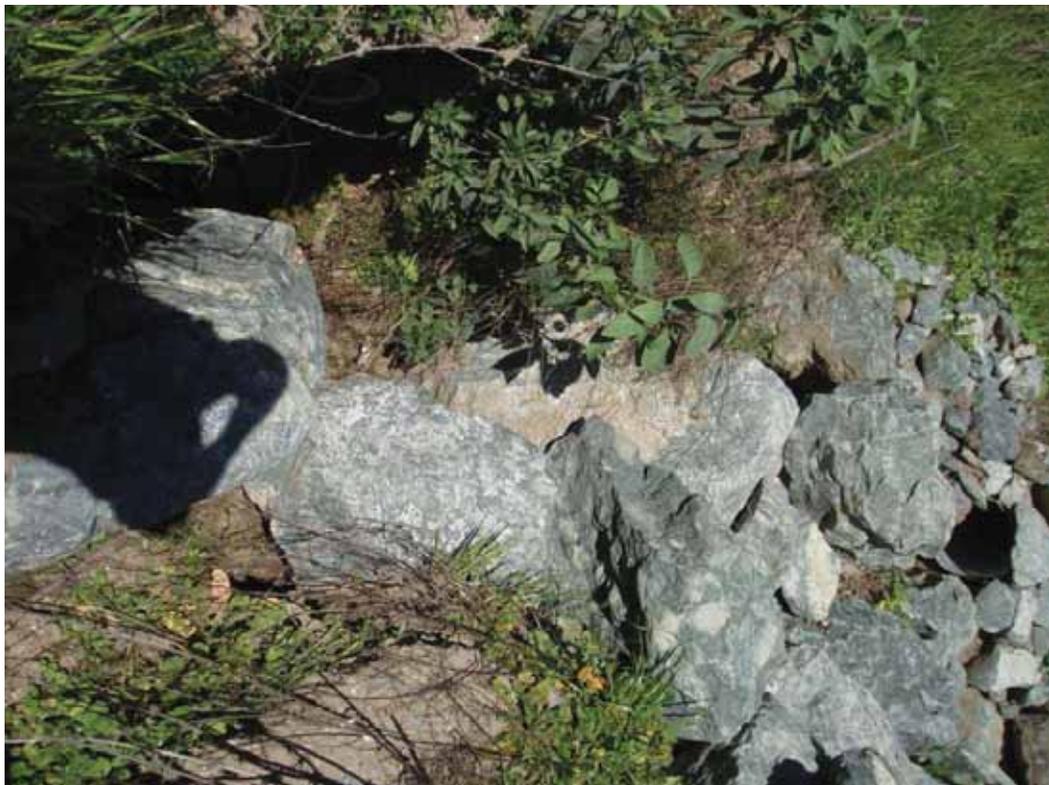
**March 2009 – Erosion and vegetation establishment at pipe outfall, Rock Barb 6**

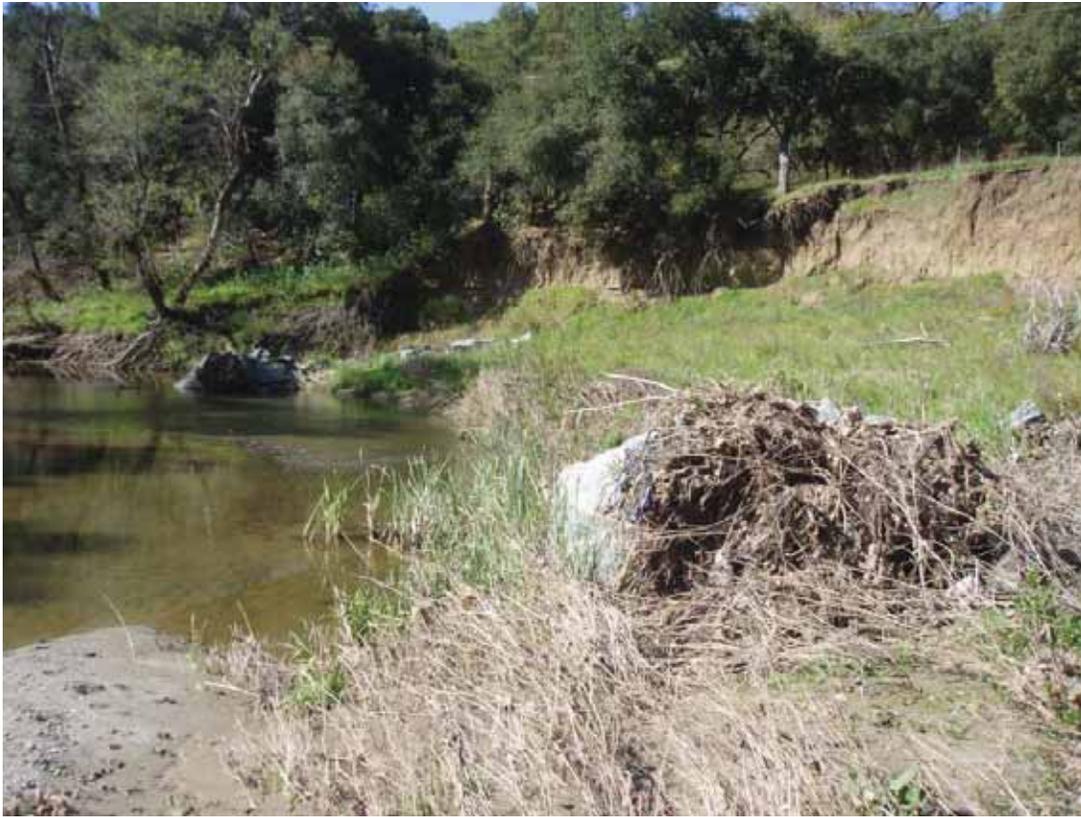
April 2009 – Aquatic vegetation and Rootwads at Rock Barbs 6 (stranded by deposition) and 7 (not stranded)

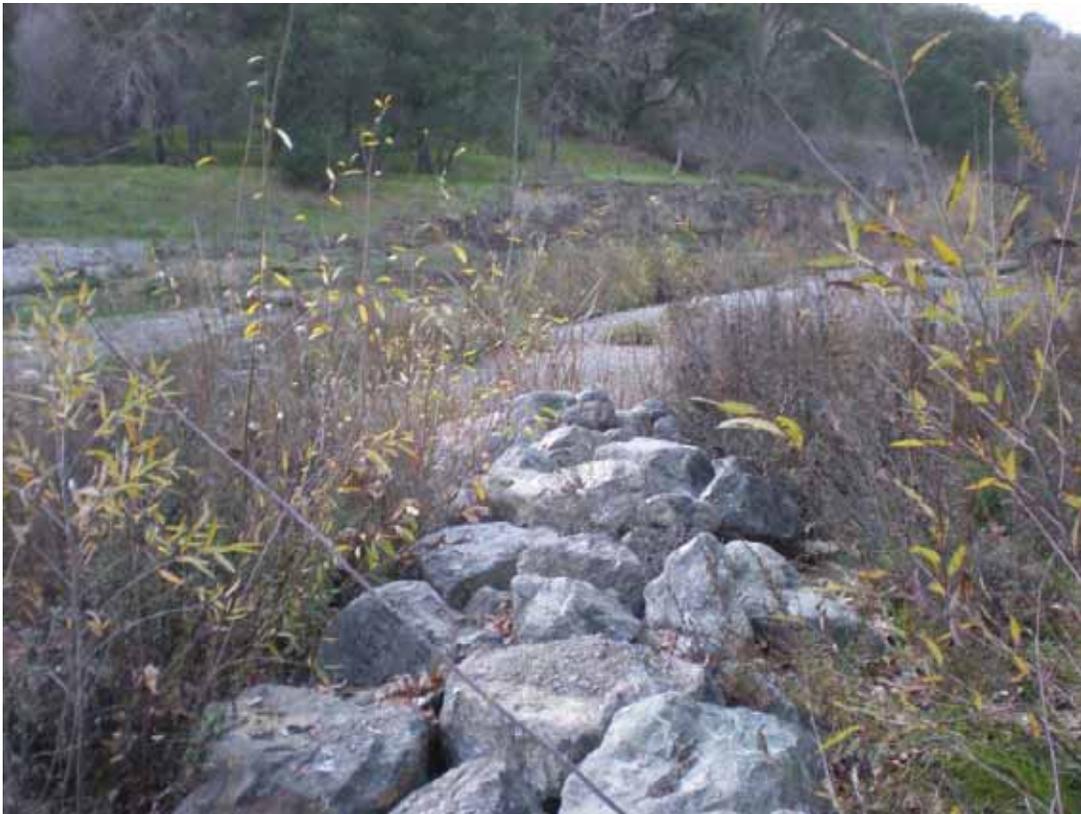
January 2009 – Willow Growth Near Rock Barb 1
