2009/2010 Annual Monitoring Report
Arroyo De La Laguna 2006 Streambank Project
Alameda County, California

Project Identification

U.S. Army Corps of Engineers File Number: 30262S
California Department of Fish and Game Notification Number: 0600-2006-0272-3
Regional Water Quality Control Board Site No.: 02-01-C0903

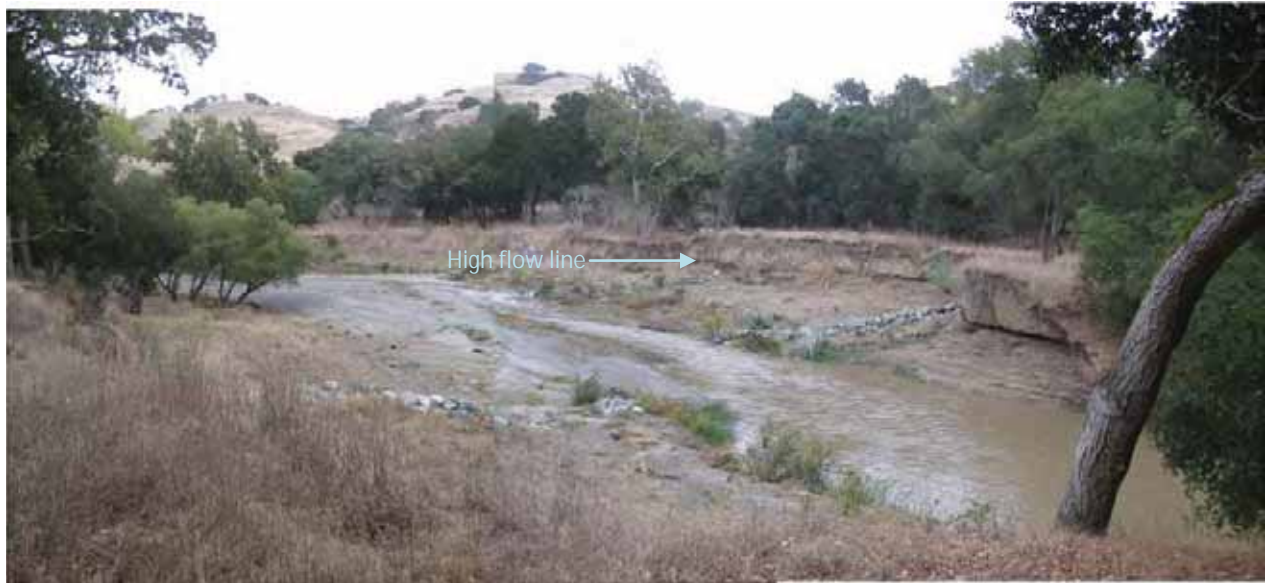
The largest flow events since the last monitoring were provisionally reported peak flows of 6,600 cfs on October 13, 2009 and 7,000 cfs on January 21, 2010.

October 2009: Site After 10-13-2009 Storm Event (provisionally 6,600 cfs, later lowered)

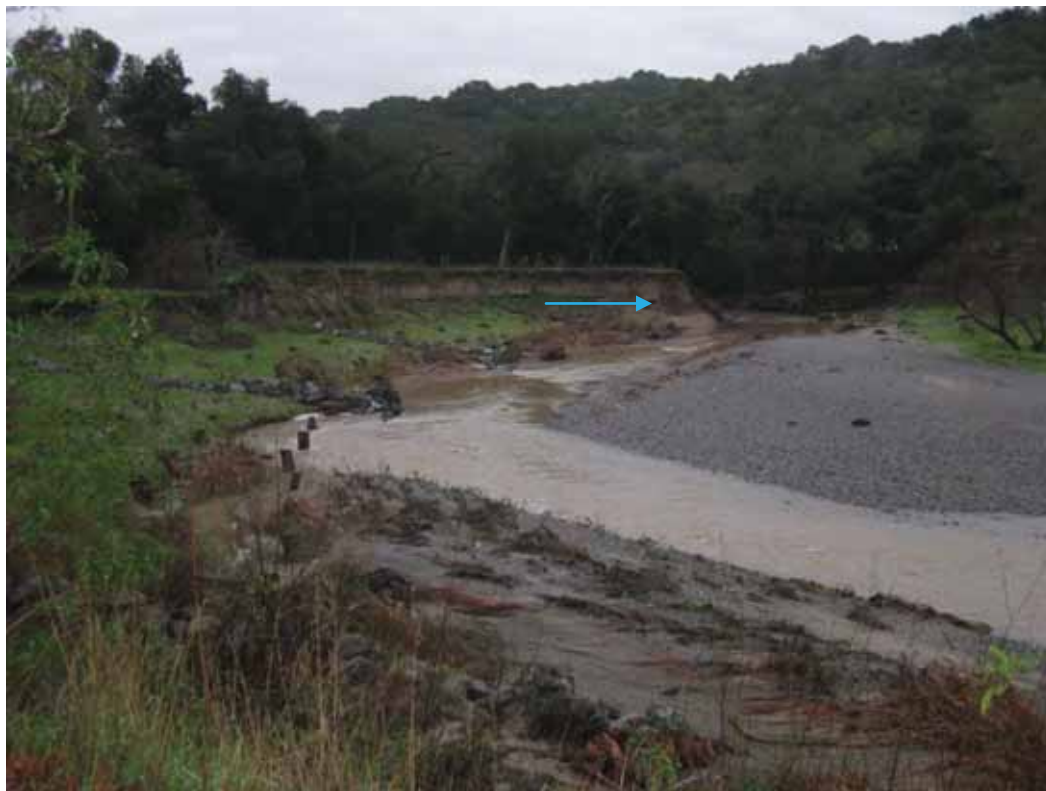
January 2010: Site After 1-21-2009 Storm Event (provisionally 7,000 cfs, later lowered)

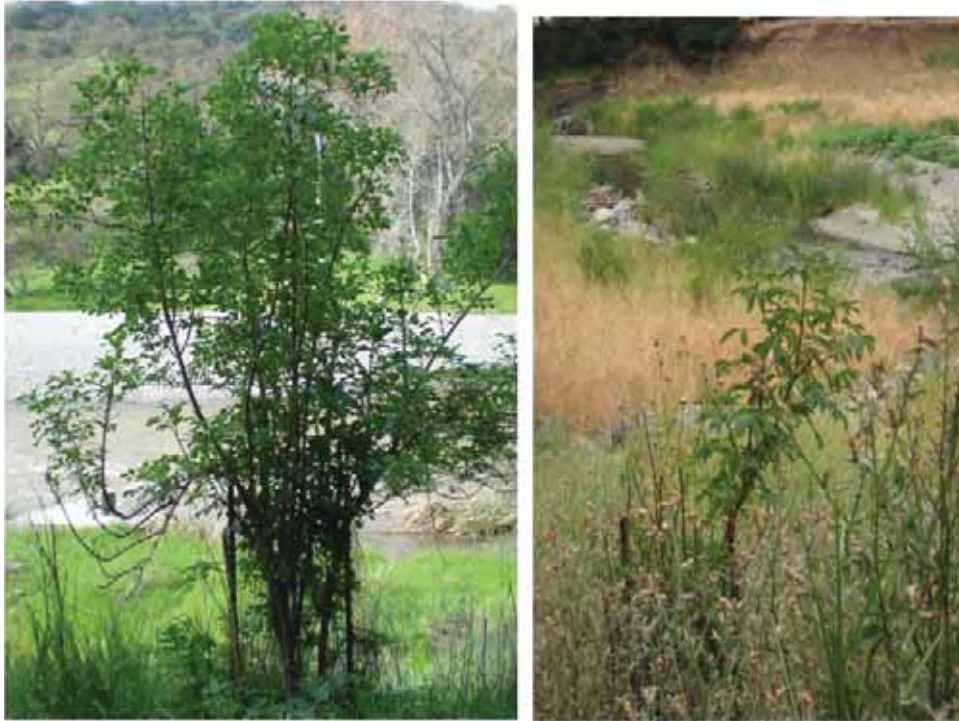
In Planting Zone 2, California buckeyes achieved 100% survival (18 trees). Elderberry, coast live oak and buckeye seedlings have begun to grow on the banks, especially where sloughing or grading during the project has decreased the slope. Several non-native tobacco plants are also growing on the banks. Willow stakes in Zone 2 and along the toe of the banks have not survived well in most of the project (less than 20%) as many were installed too high on the terraces to survive the drought years. New willow stakes are planned in conjunction with an irrigation system in order to establish willows in Zone 2, especially along the toe of the banks.

March 2010 – Vegetation Growth (left: elderberry, right: buckeye, background aquatic vegetation)

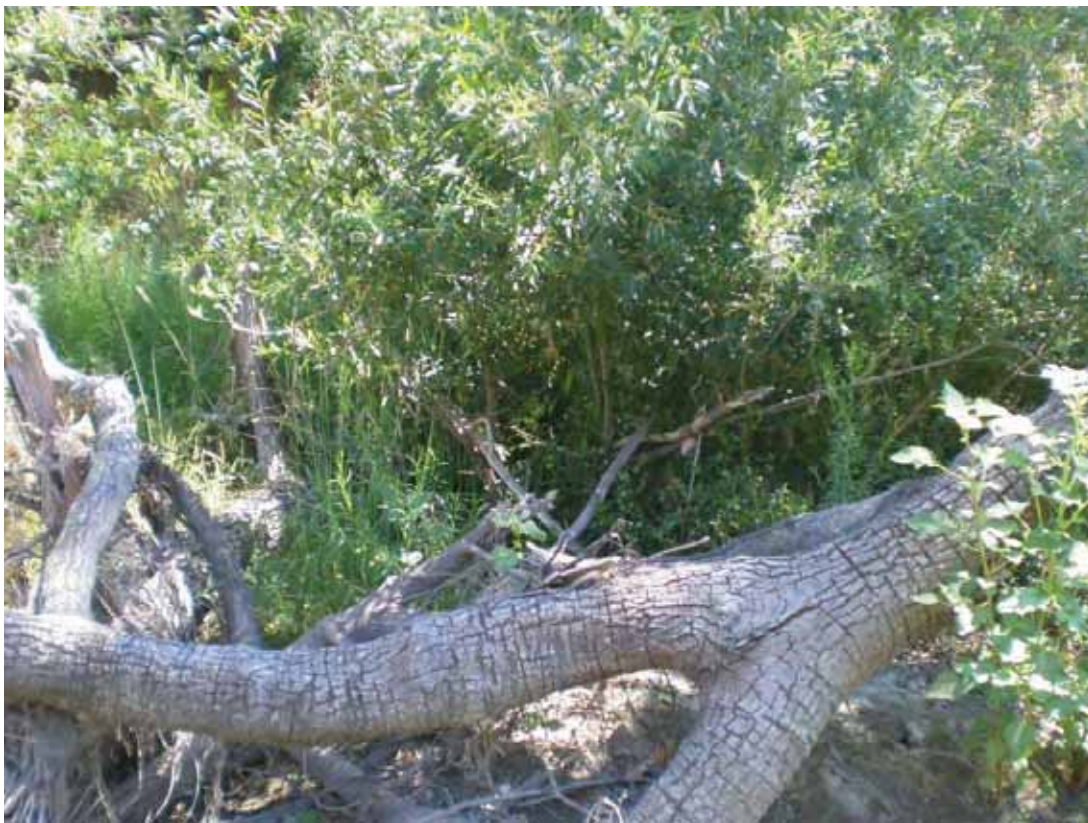
is present. Although annual grasses are still prevalent, native grasses and other native species such as creeping wildrye, purple needlegrass and mugwort were relatively much more successful this year than in past years. An inventory of plant species identified at the site in April 2009 is included in Appendix B. The edges of the stream channel are dominated by: willows, cattails, rushes, sedges, cocklebur and sweet clover. Willow stake survival in Zone 1 is over 80%. The new willow stakes installed in November 2007 replaced any willows lost since construction in this zone and natural willows have begun establishing on the terraces closer to the stream (see photo).

July 2010 – Willow Growth and Large Wood Recruitment Near Willow Brush Spur
