2009/2010 Annual Monitoring Report
Arroyo De La Laguna 2006 Streambank Project
Alameda County, California

Project Identification

U.S. Army Corps of Engineers File Number: 30262S
California Department of Fish and Game Notification Number: 0600-2006-0272-3
Regional Water Quality Control Board Site No.: 02-01-C0903

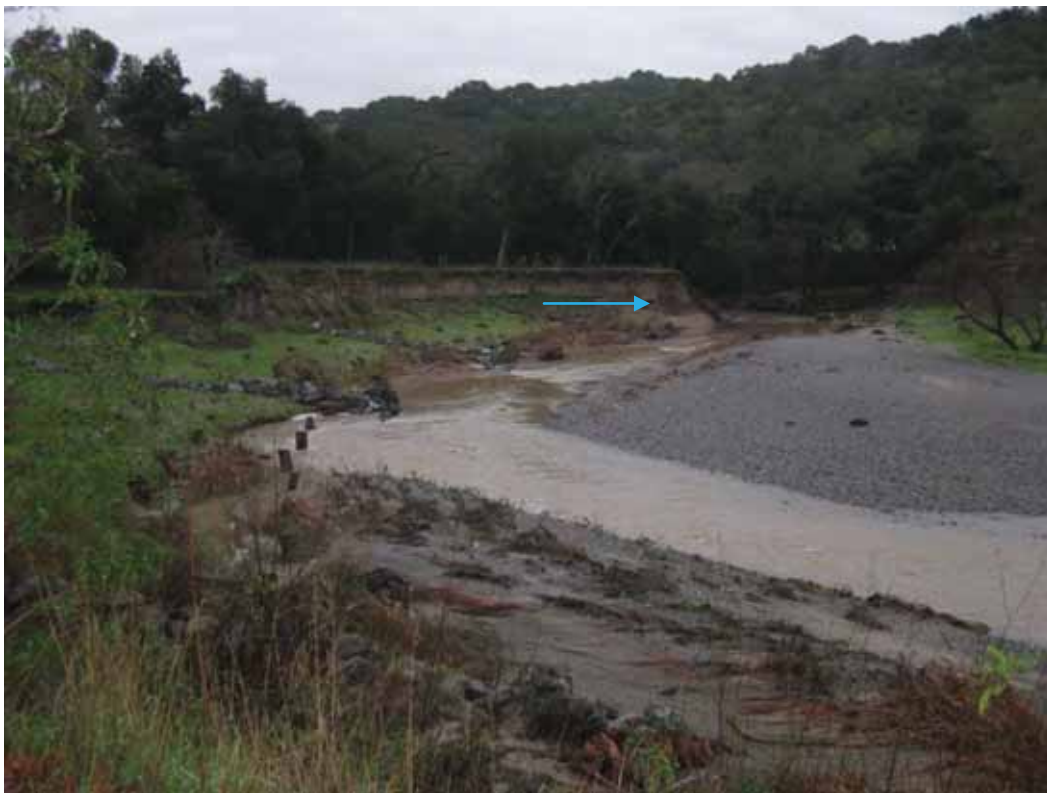
January 2010: Site After 1-21-2009 Storm Event (provisionally 7,000 cfs, later lowered)

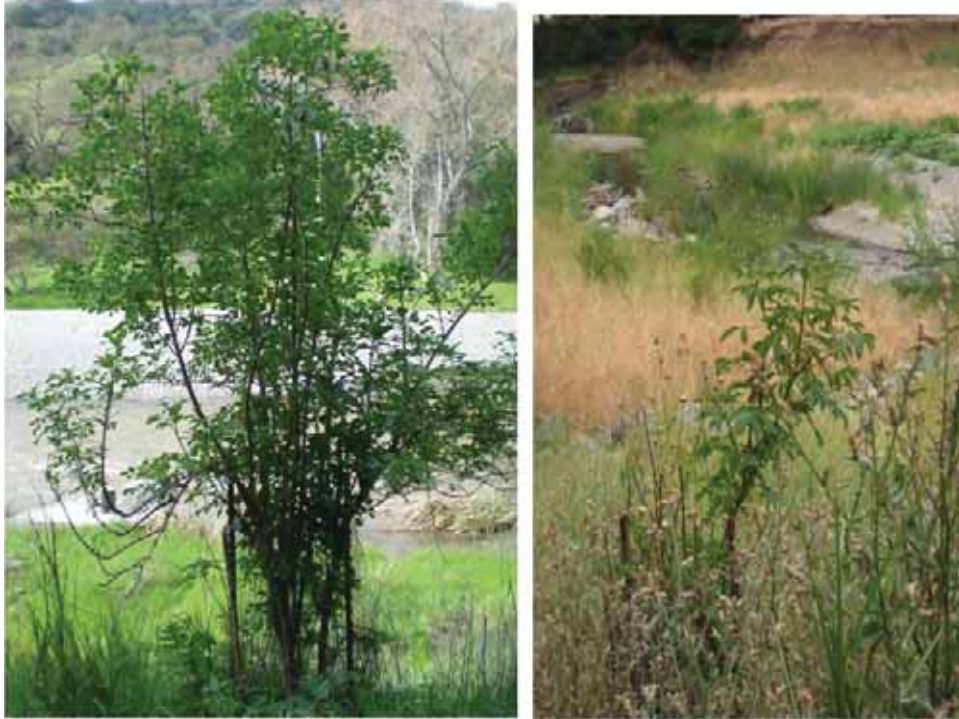
In Planting Zone 2, California buckeyes achieved 100% survival (18 trees). Elderberry, coast live oak and buckeye seedlings have begun to grow on the banks, especially where sloughing or grading during the project has decreased the slope. Several non-native tobacco plants are also growing on the banks. Willow stakes in Zone 2 and along the toe of the banks have not survived well in most of the project (less than 20%) as many were installed too high on the terraces to survive the drought years. New willow stakes are planned in conjunction with an irrigation system in order to establish willows in Zone 2, especially along the toe of the banks.

March 2010 – Vegetation Growth (left: elderberry, right: buckeye, background aquatic vegetation)

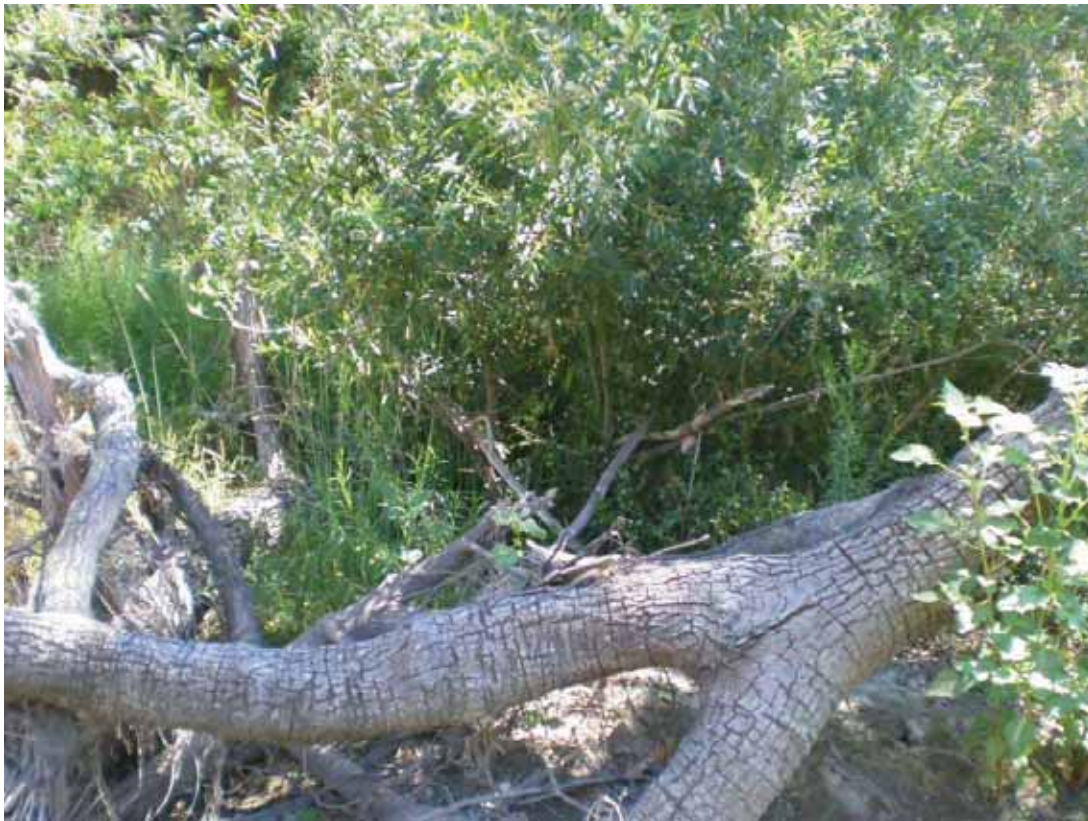
is present. Although annual grasses are still prevalent, native grasses and other native species such as creeping wildrye, purple needlegrass and mugwort were relatively much more successful this year than in past years. An inventory of plant species identified at the site in April 2009 is included in Appendix B. The edges of the stream channel are dominated by: willows, cattails, rushes, sedges, cocklebur and sweet clover. Willow stake survival in Zone 1 is over 80%. The new willow stakes installed in November 2007 replaced any willows lost since construction in this zone and natural willows have begun establishing on the terraces closer to the stream (see photo).

July 2010 – Willow Growth and Large Wood Recruitment Near Willow Brush Spur

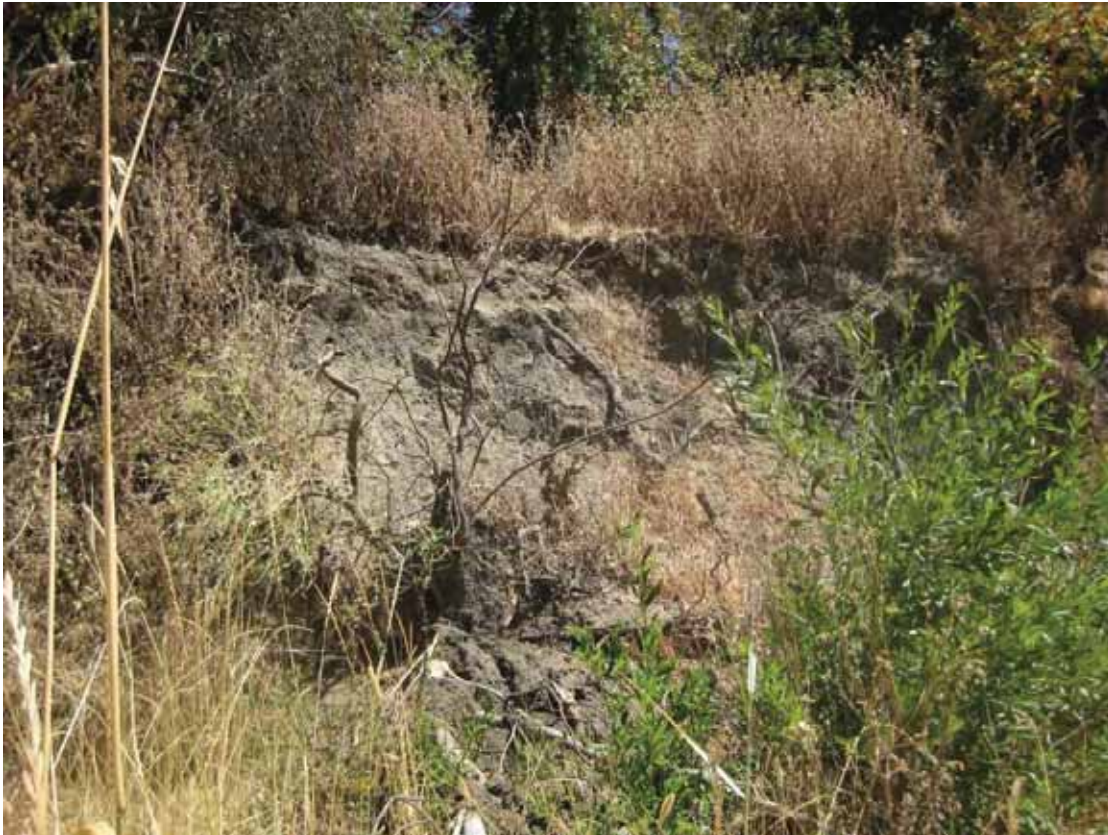
Bank erosion did occur during this monitoring period in the form of bank sloughing during drawdown after storm events. One small buckeye tree was lost from the bank (see photograph). Vegetation has established on the soil sloughed during storm events during previous winters.

July 2010 – Small buckeye (roots shown) lost from top of bank due to sloughing

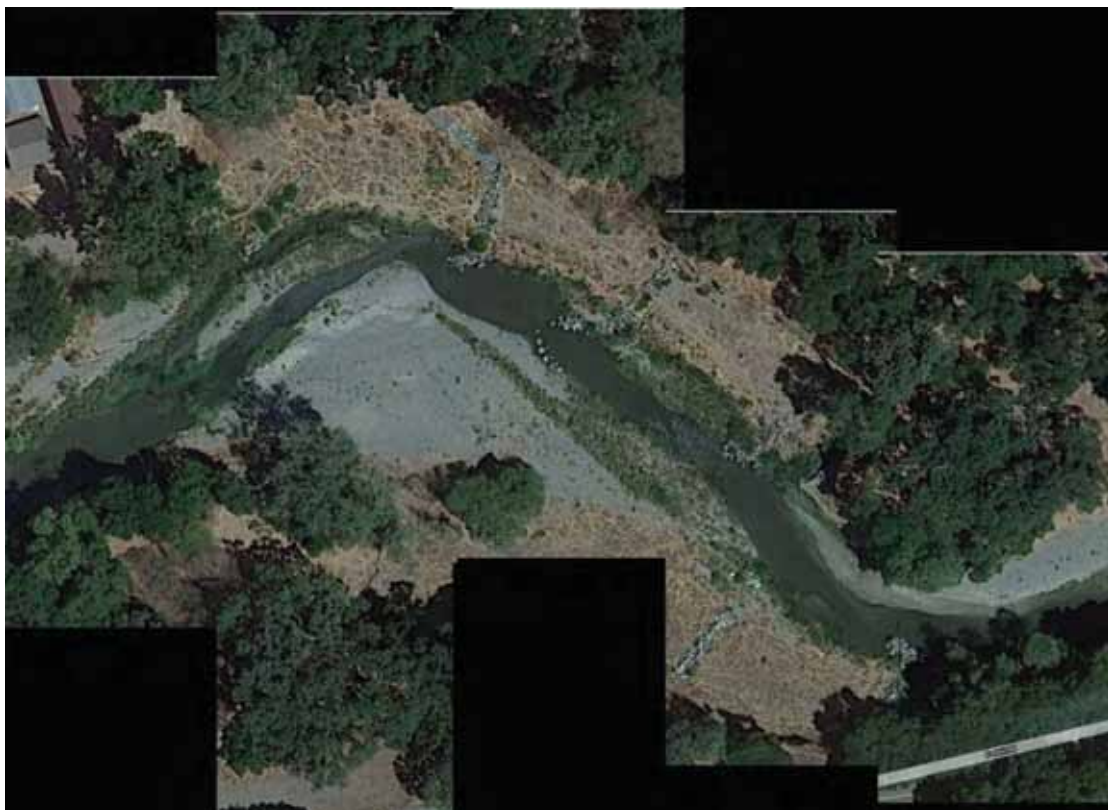
No headcuts or nick points are visible in the channel reach. No evidence of significant incision or aggradation of the channel bed was seen. Some erosion of the terrace toe occurred between Rock Barb 2 and Rock Barb 3 in 2006/2007, but the erosion has not impacted the bank and there has been some recent deposition along the toe of the terrace where the scalloping had occurred. Rootwads, other large woody debris and willow brush spurs will be installed in this area in 2010 in order to provide additional roughness and toe stability as well as aquatic habitat. Sediment build up is evident on the constructed terraces between rock barbs (this is desirable for the project) and on the inside stream curves.

2009-2010 Aerial – Shows areas of deposition and formation of pools and riffles
