2010/2011 Annual Monitoring Report

Arroyo De La Laguna
Alameda County, California

U.S. Army Corps of Engineers File Number: 30262S
California Department of Fish and Game Notification Number: 0600-2006-0272-3
Regional Water Quality Control Board Site No.: 02-01-C0903

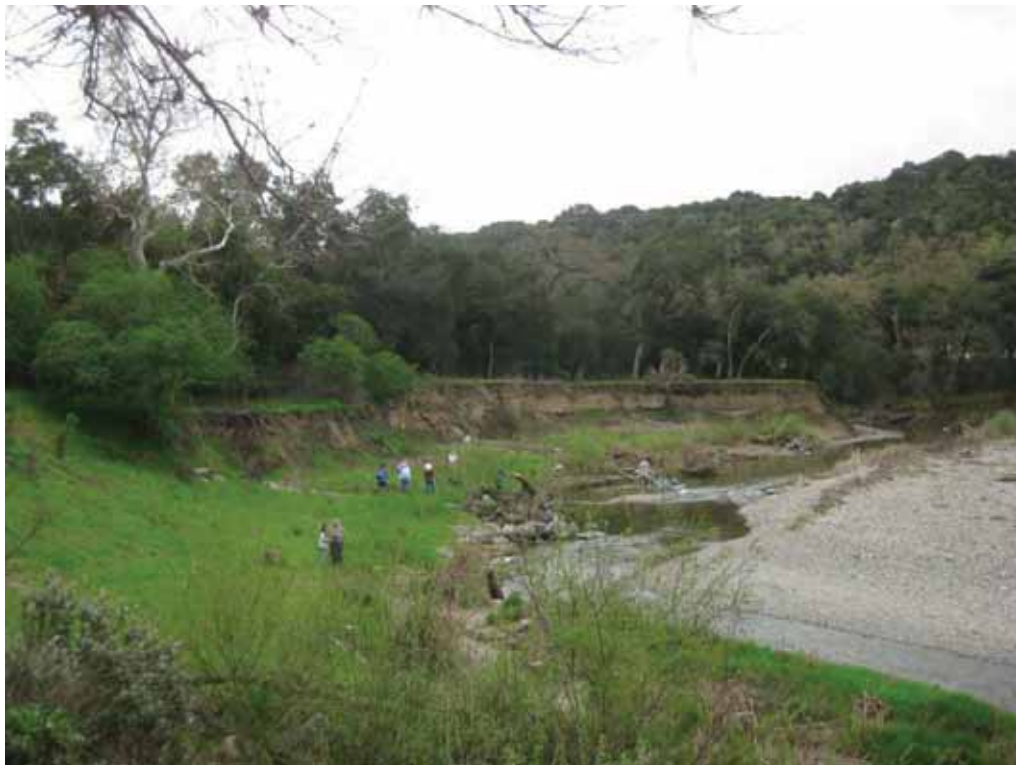
March 11 2011: Site Before March 24, 2011 Storm Event

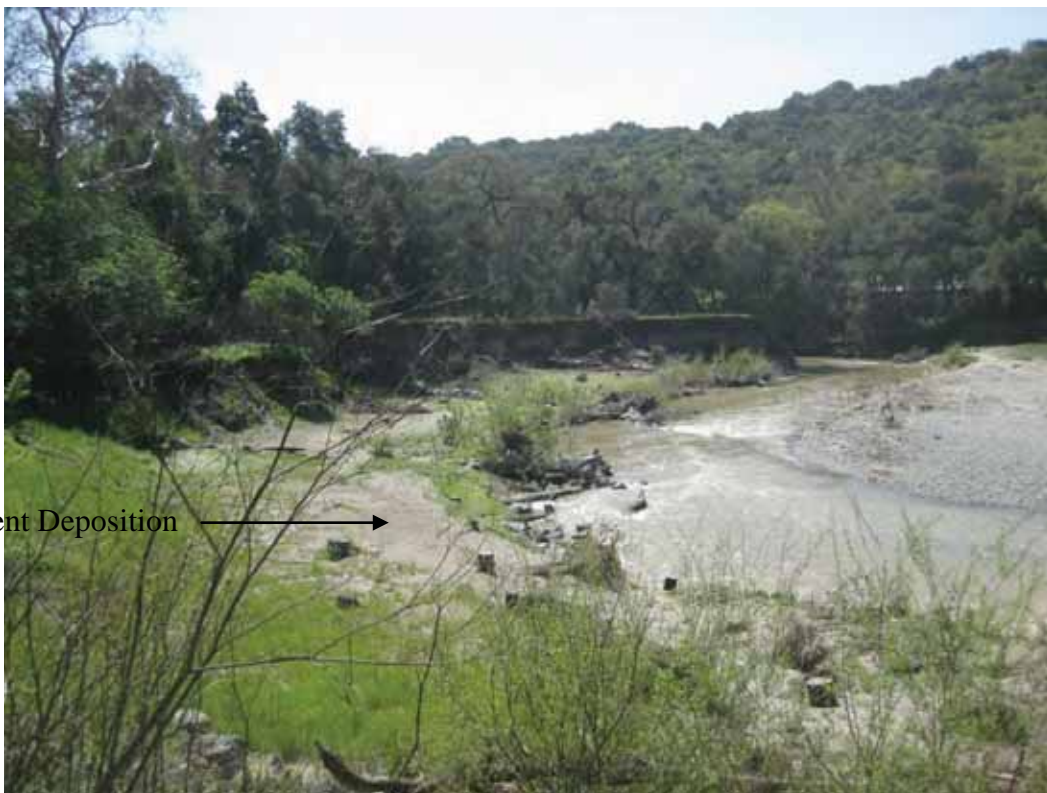
Bank erosion did occur during this monitoring period in the form of bank sloughing during drawdown after storm events. Vegetation has established on the soil sloughed during storm events during previous winters.

Sediment Deposition →

March 29 2011: Site After March 24, 2011 Storm Event

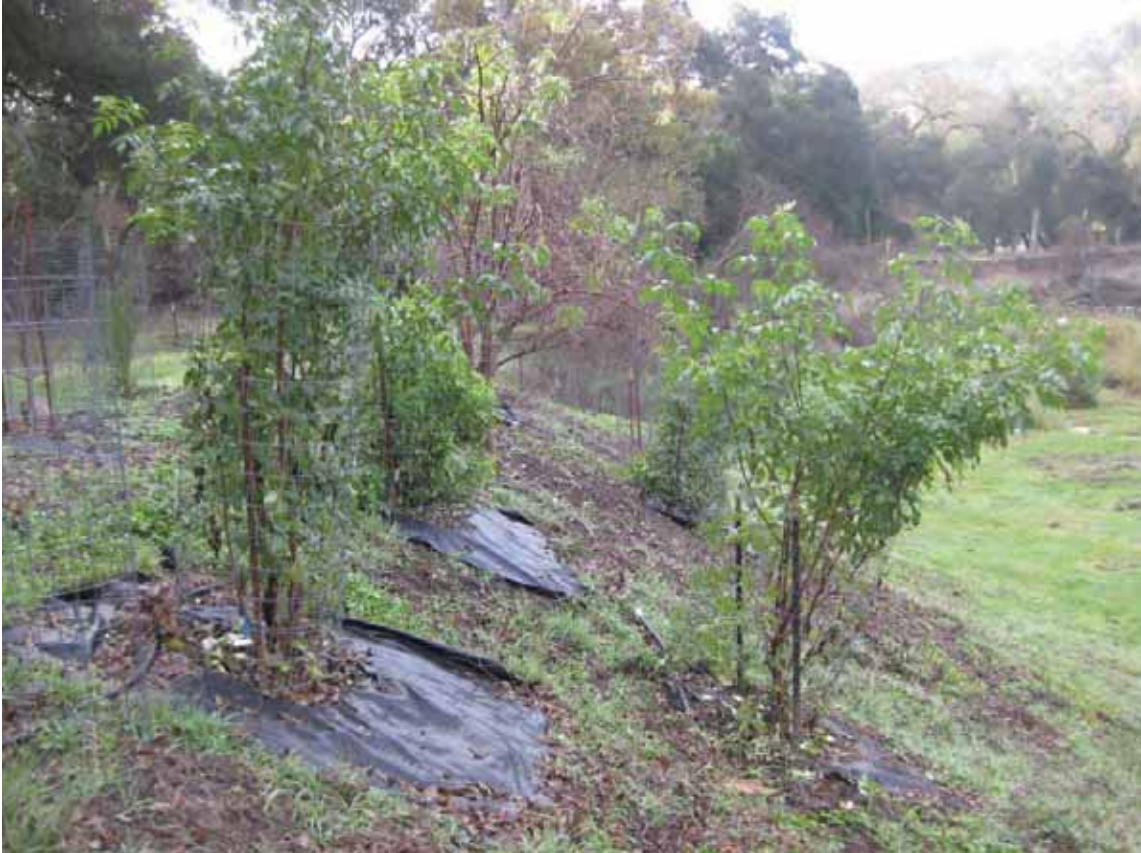
November 2011 – Vegetation Growth (elderberry and buckeye)

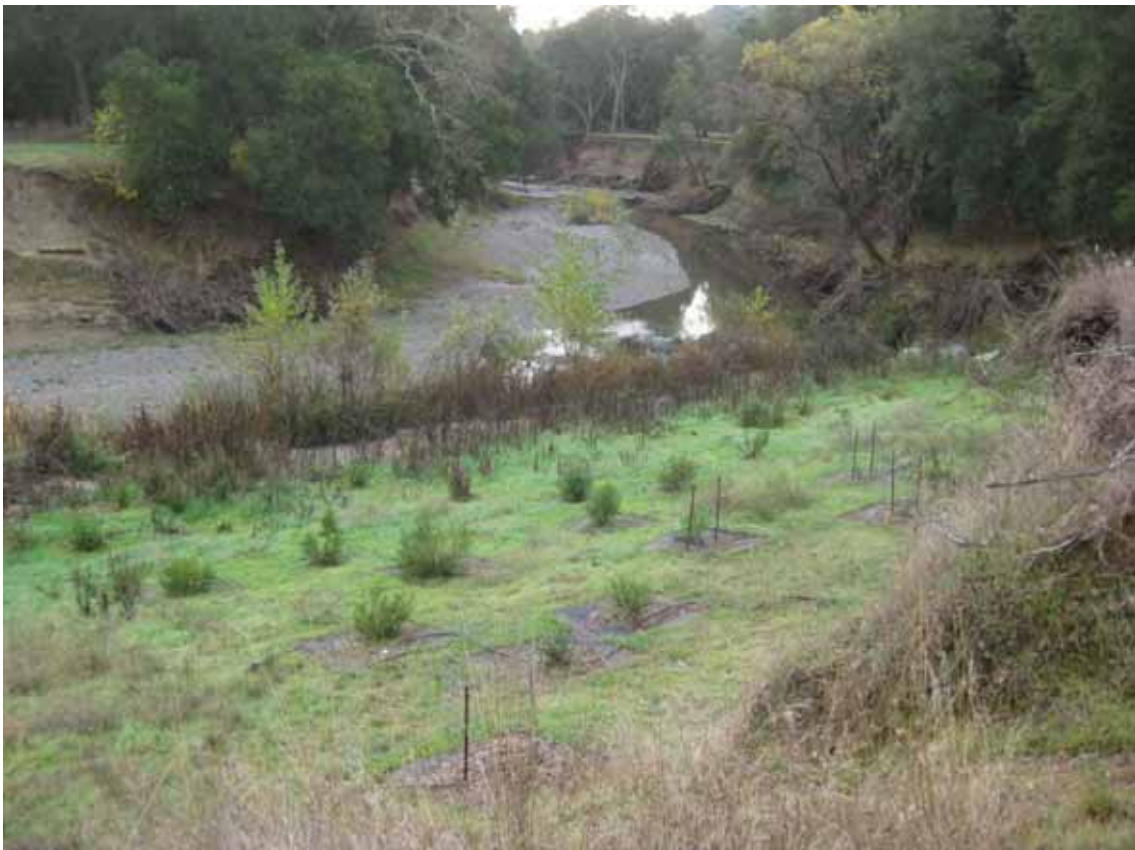
November 2011 – Recent Plantings on West Bank

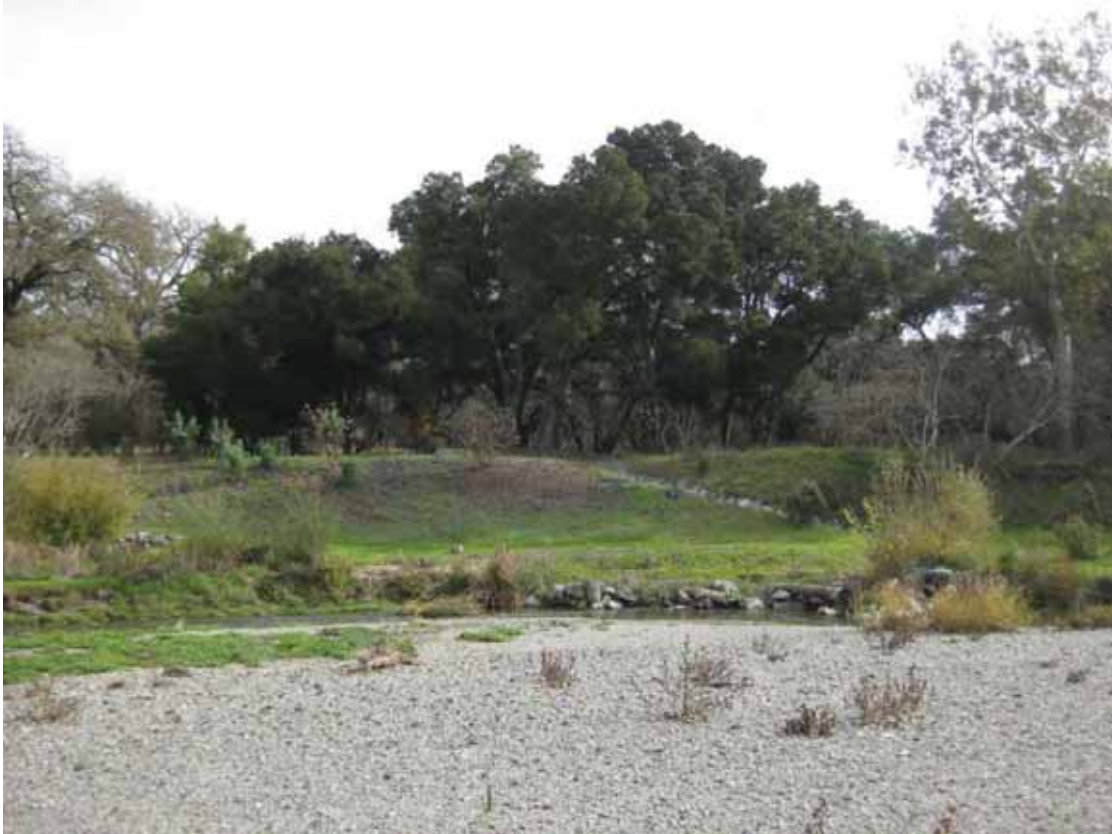
November 2011: Post-Installation of Additional Rootwads

For the most part, the structural features (not including vegetative plantings) were stable, had no issues with seating or scour, and require no maintenance. Exceptions noted in past monitoring reports (e.g. practices that have been covered by sediment deposition or experienced slight movement due to erosion) have not worsened and none are considered to threaten the success of the project. Several soil anchors were tightened in Summer 2010. Additional rootwads were installed between Rock Barb 2 and Rock Barb 3 in Summer 2010.

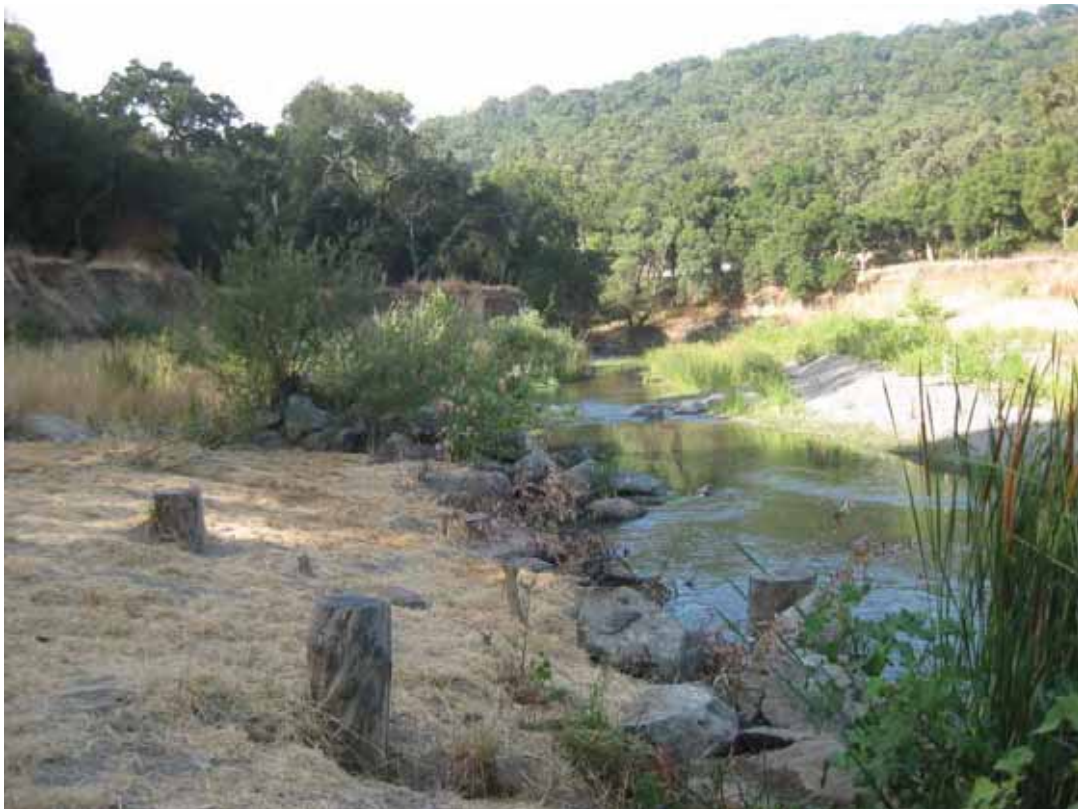
August 2010: Post-Installation of Additional Rootwads
