2010/2011 Annual Monitoring Report

Arroyo De La Laguna
Alameda County, California

U.S. Army Corps of Engineers File Number: 30262S
California Department of Fish and Game Notification Number: 0600-2006-0272-3
Regional Water Quality Control Board Site No.: 02-01-C0903

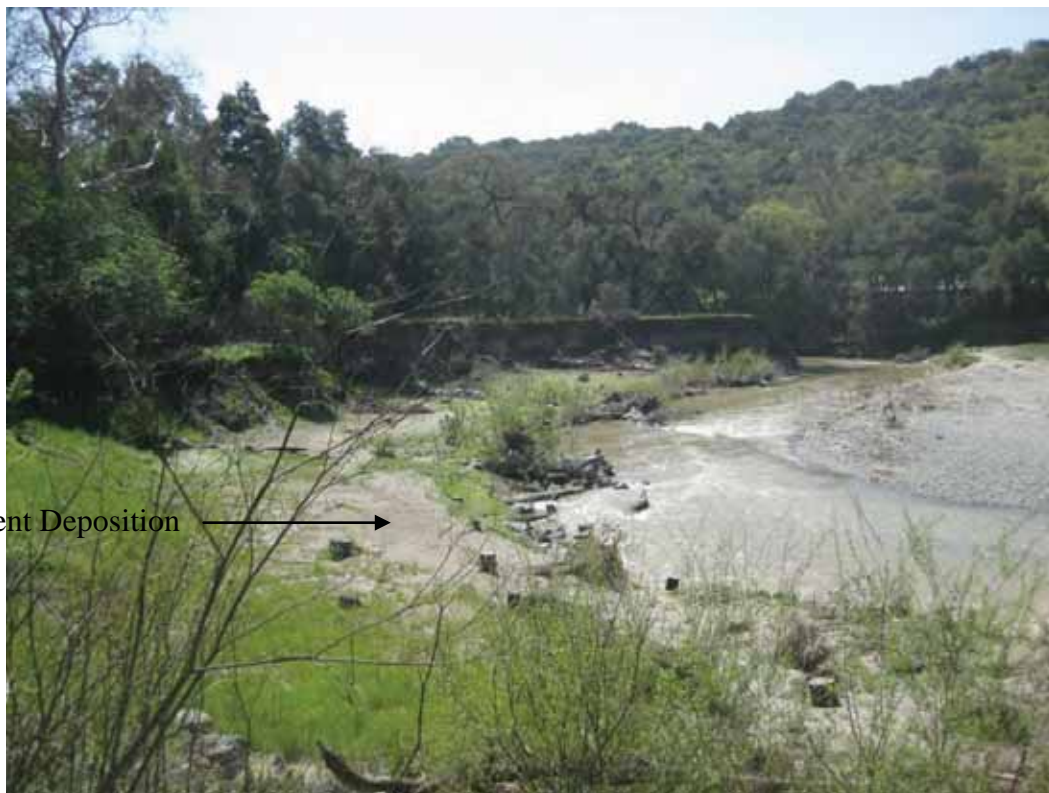
Bank erosion did occur during this monitoring period in the form of bank sloughing during drawdown after storm events. Vegetation has established on the soil sloughed during storm events during previous winters.

Sediment Deposition →

March 29 2011: Site After March 24, 2011 Storm Event
