2007/2008 Annual Monitoring Report

Arroyo De La Laguna
Alameda County, California

U.S. Army Corps of Engineers File Number: 30262S
California Department of Fish and Game Notification Number: 0600-2006-0272-3
Regional Water Quality Control Board Site No.: 02-01-C0903

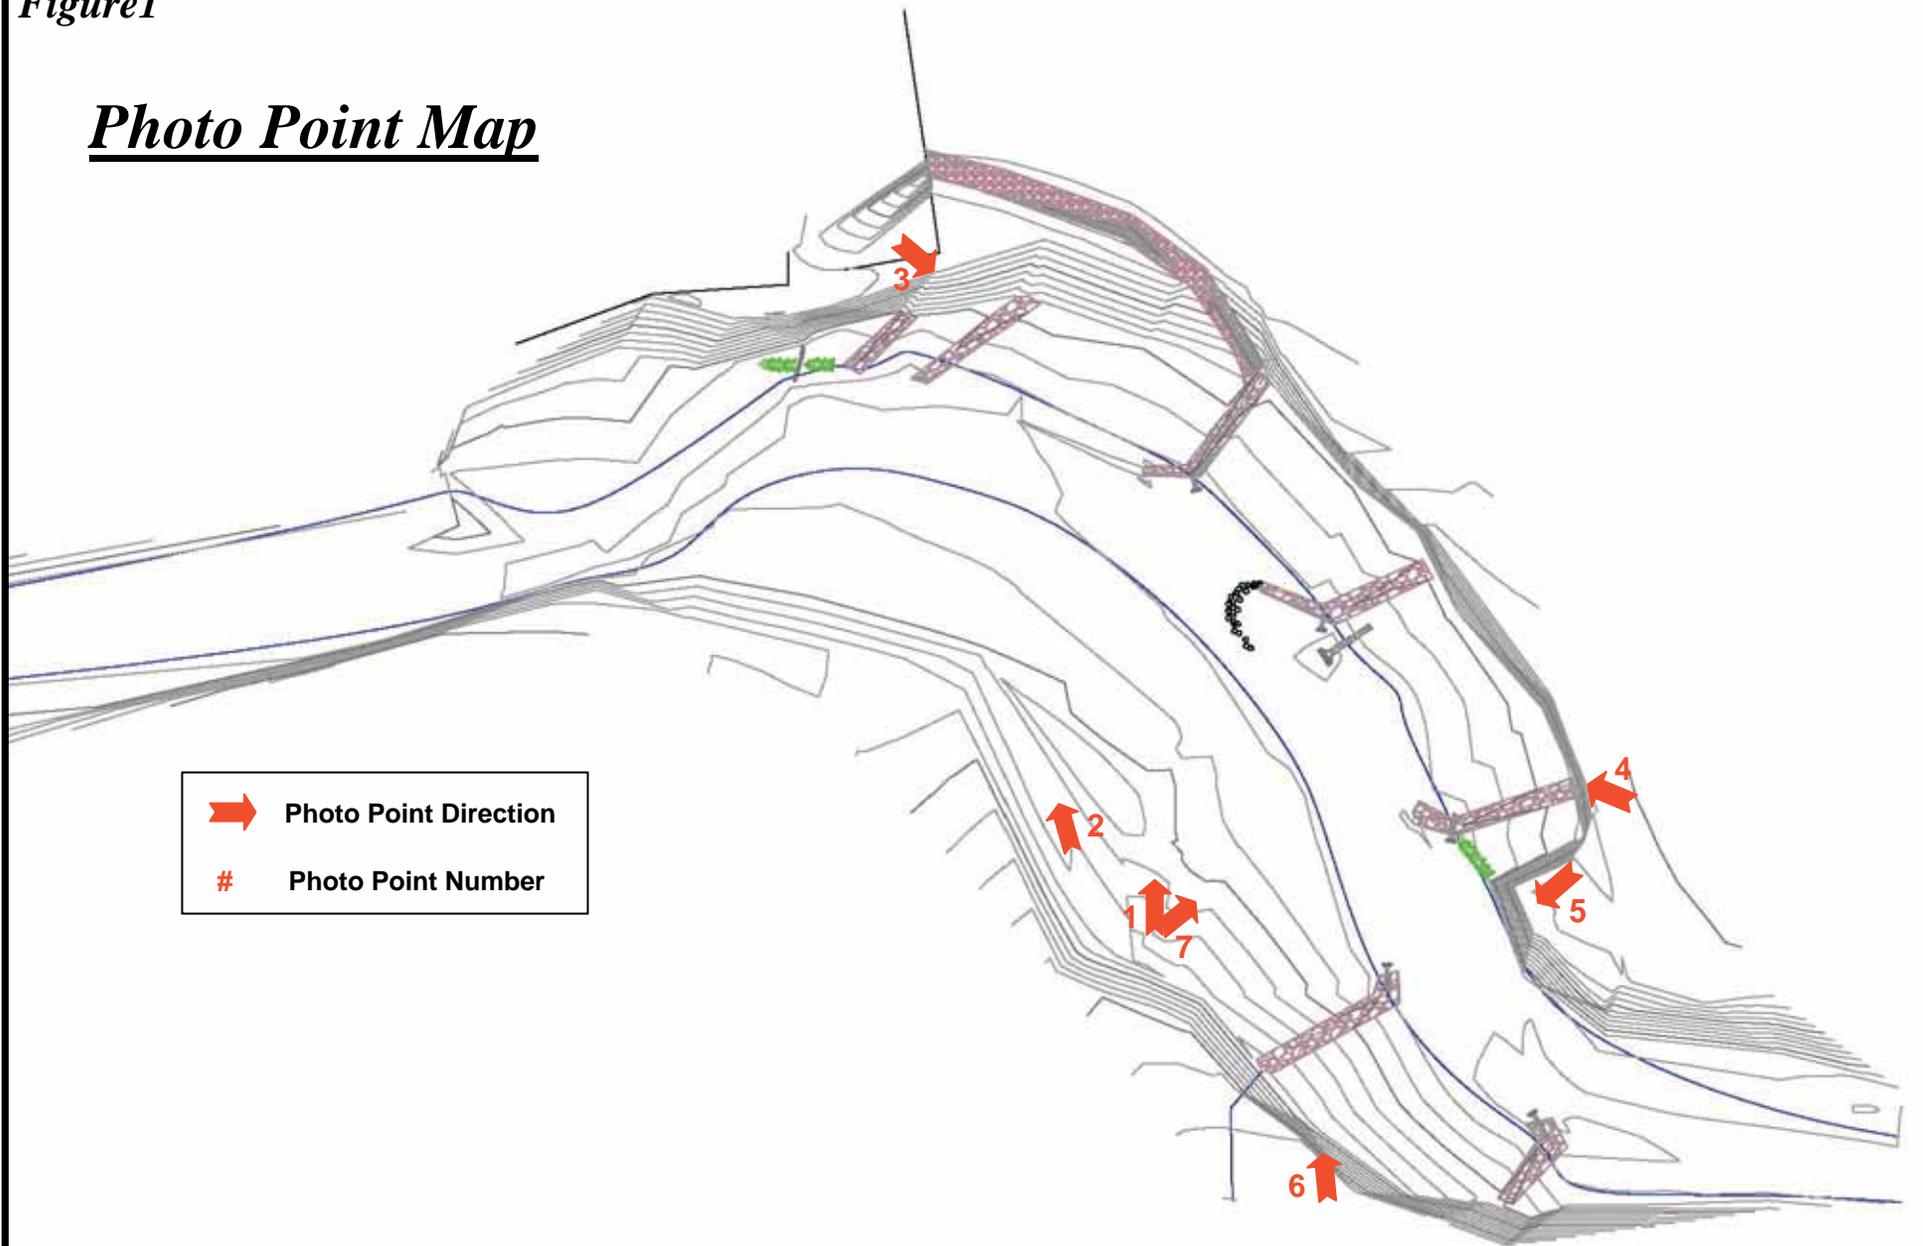
Figure 1

Photo Point Map

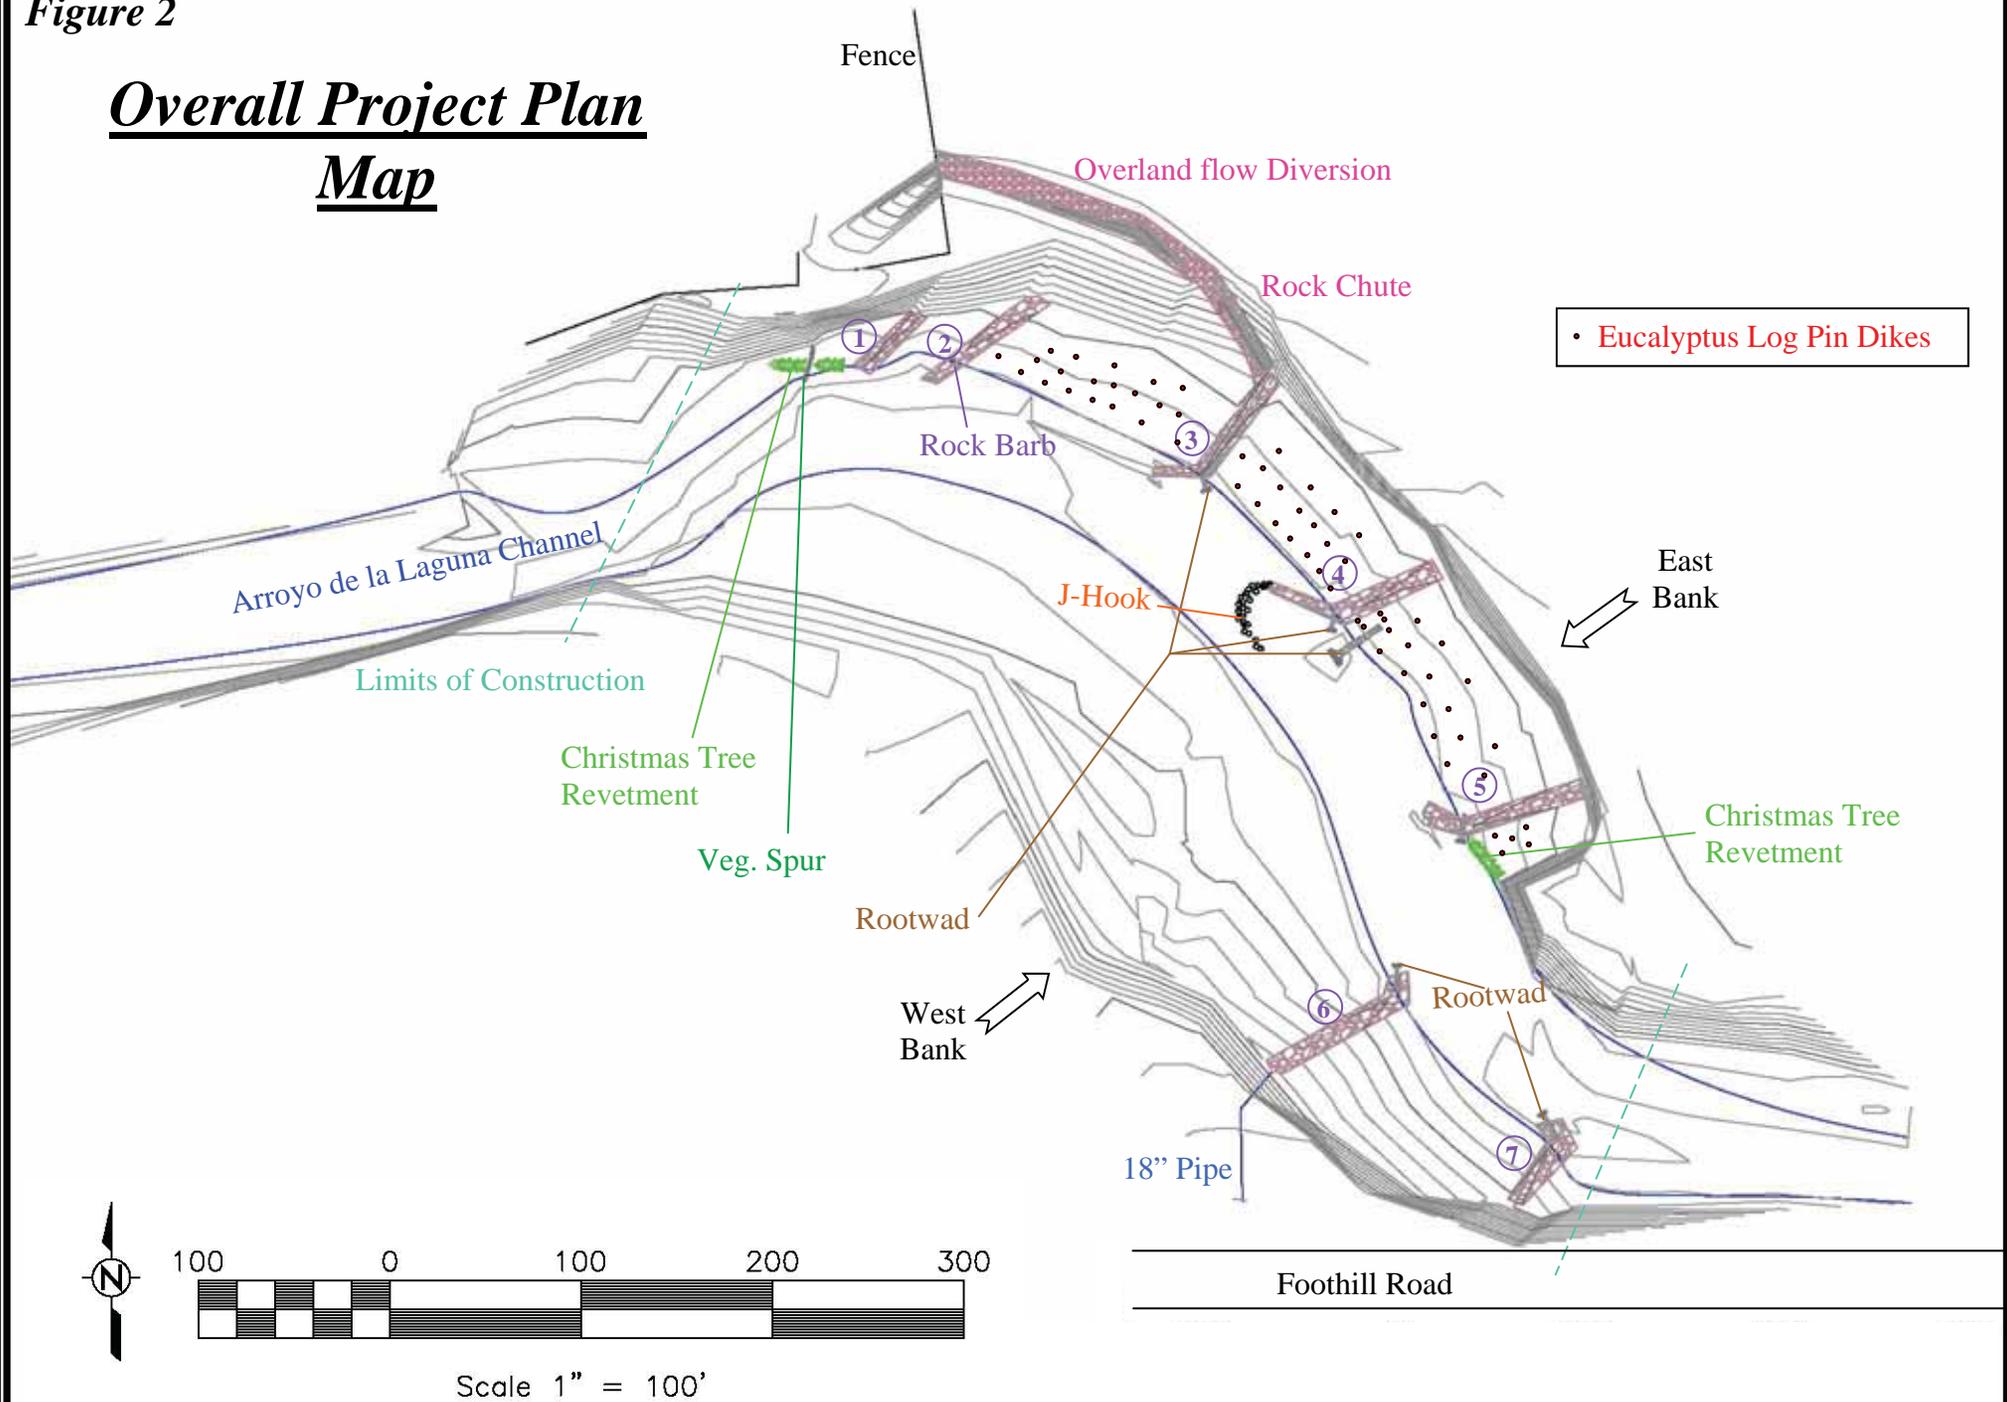
Figure 2 shows the overall project plan and the location of streambank protection practices not including vegetative practices. Figure 3 shows the As-Built Vegetation Plan.

Overall Project Plan Map

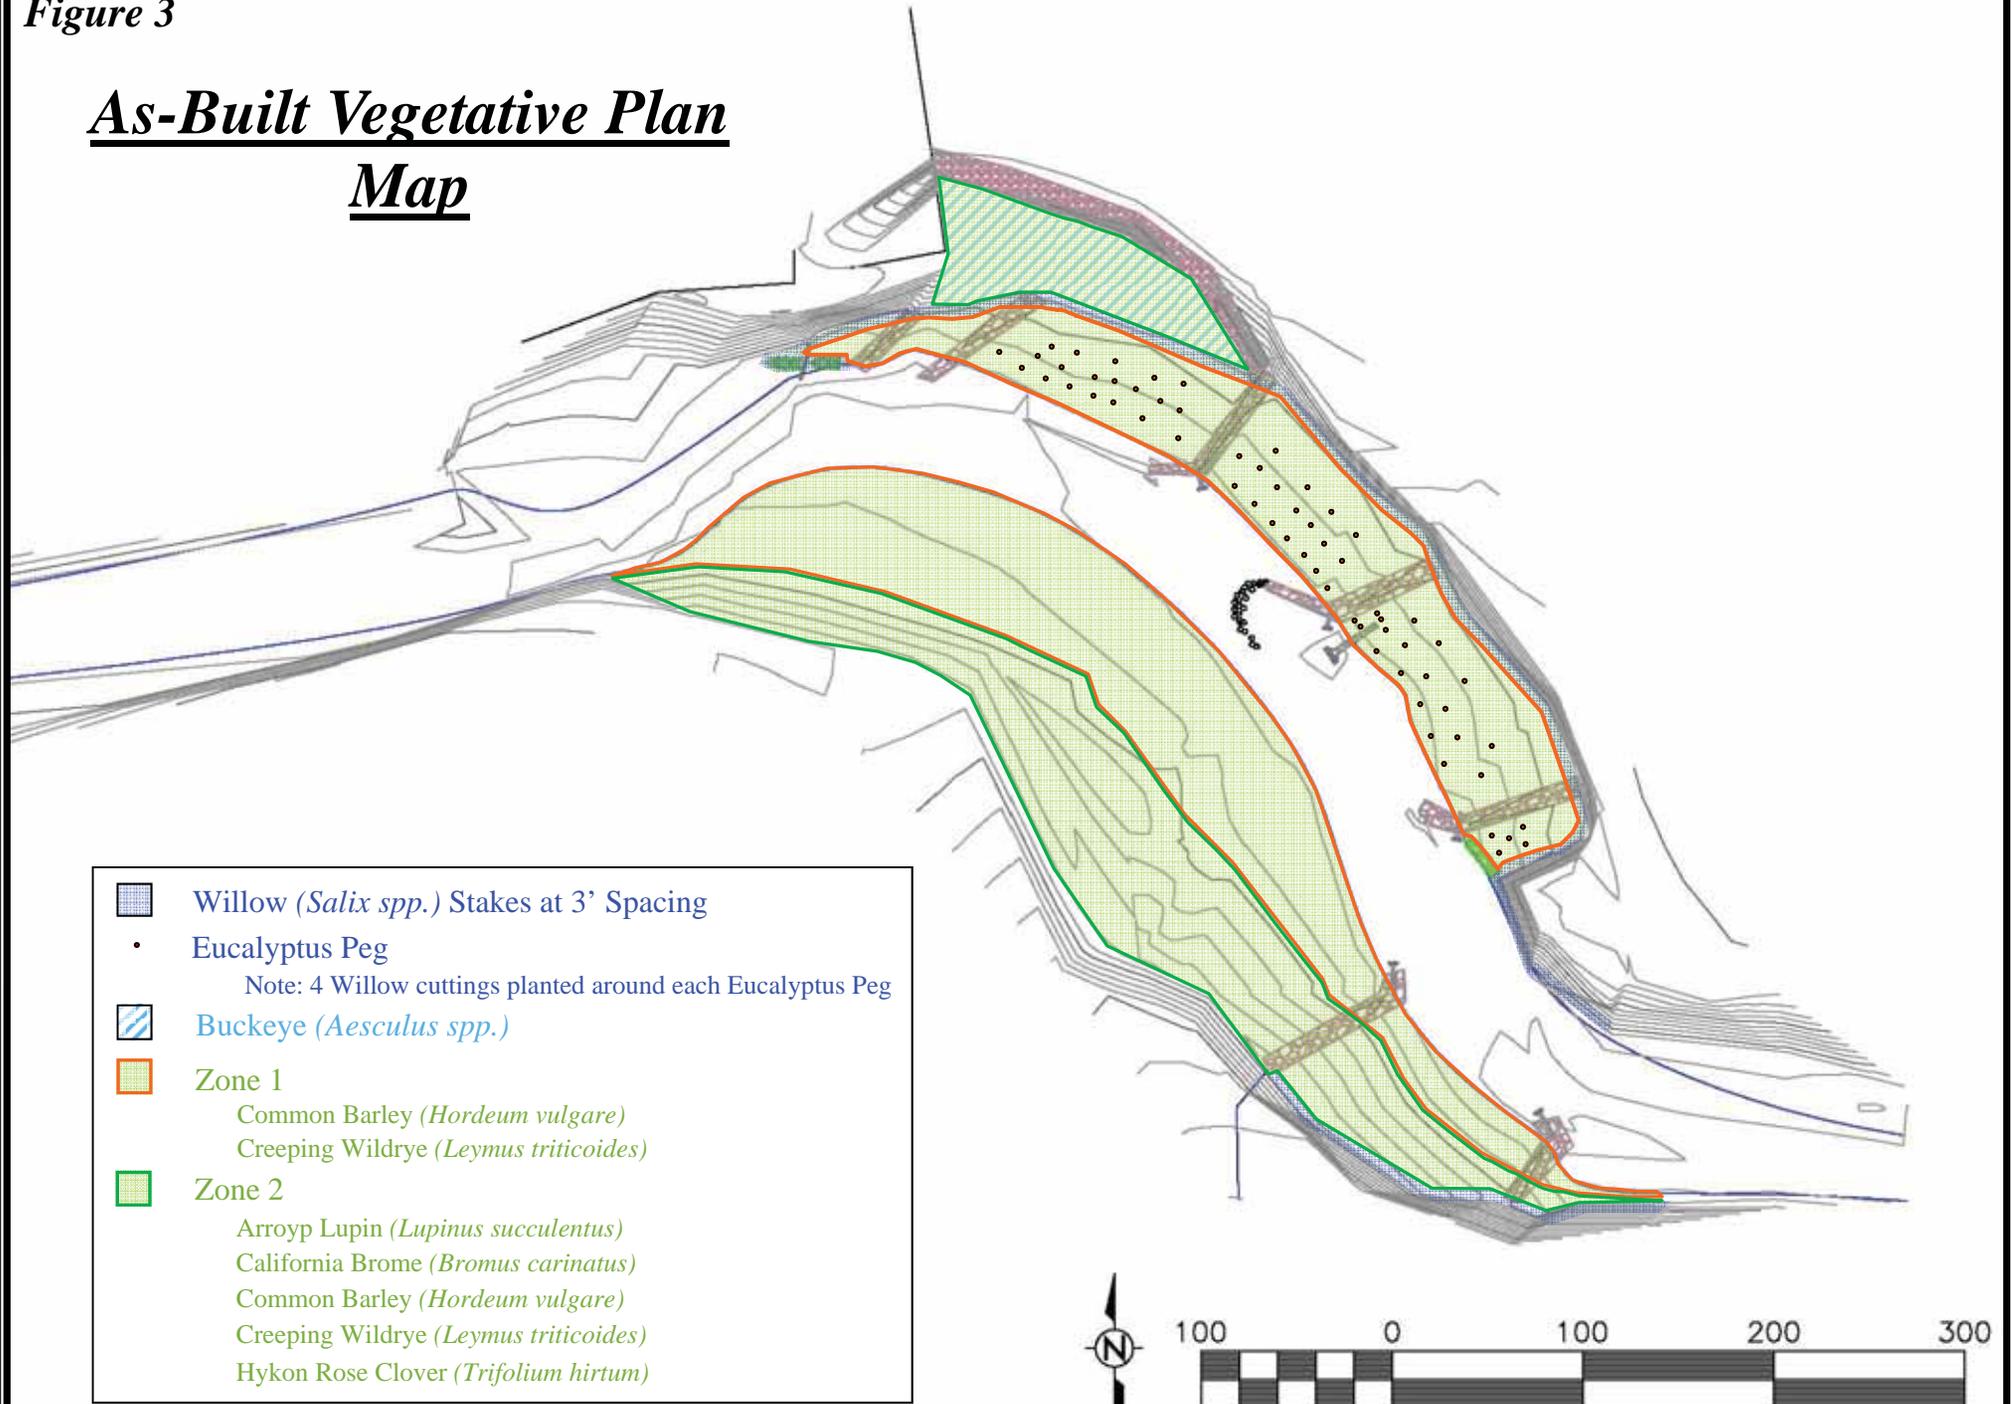
Figure 3

The “As Built” Vegetation Map (Figure 3) shows the vegetation plantings as of June 2007 including type, number and locations. In addition, over 100 willow stakes were installed in November 2007 to further enhance the site and replace stakes lost during the year. These stakes were installed in Zone 1, mostly along the Rock Barbs and the channel edge.

As-Built Vegetative Plan Map
