2010/2011 Annual Monitoring Report

Arroyo De La Laguna
Alameda County, California

U.S. Army Corps of Engineers File Number: 30262S
California Department of Fish and Game Notification Number: 0600-2006-0272-3
Regional Water Quality Control Board Site No.: 02-01-C0903

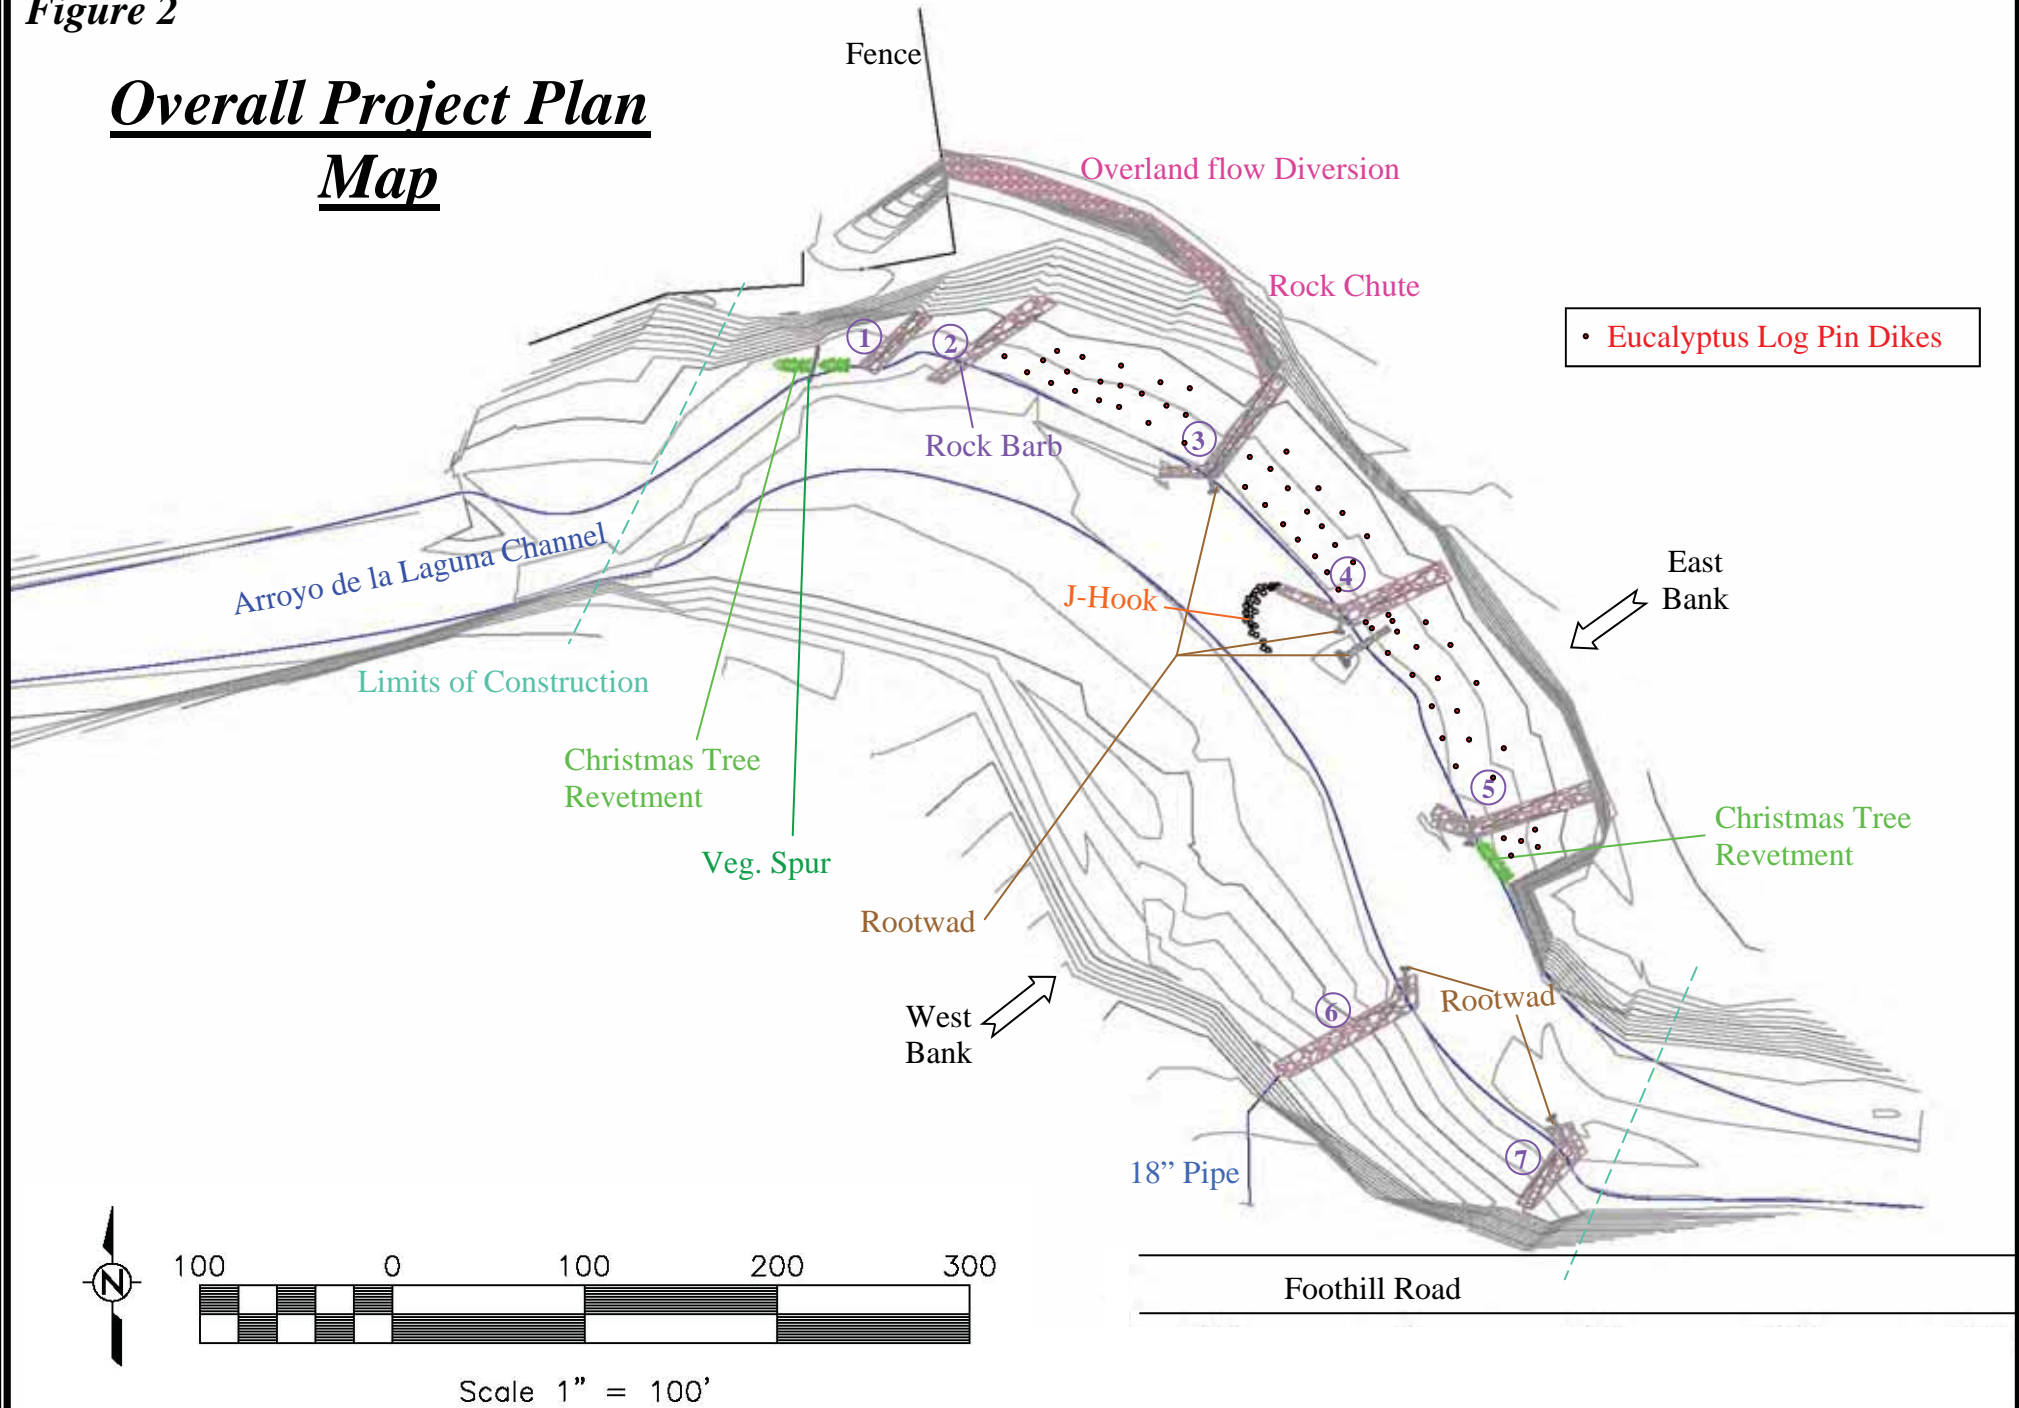
Figure 2 shows the overall project plan and the location of streambank protection practices not including vegetative practices. Figure 3 shows the As-Built Vegetation Plan.

For the most part, the structural features (not including vegetative plantings) were stable, had no issues with seating or scour, and require no maintenance. Exceptions noted in past monitoring reports (e.g. practices that have been covered by sediment deposition or experienced slight movement due to erosion) have not worsened and none are considered to threaten the success of the project. Several soil anchors were tightened in Summer 2010. Additional rootwads were installed between Rock Barb 2 and Rock Barb 3 in Summer 2010.

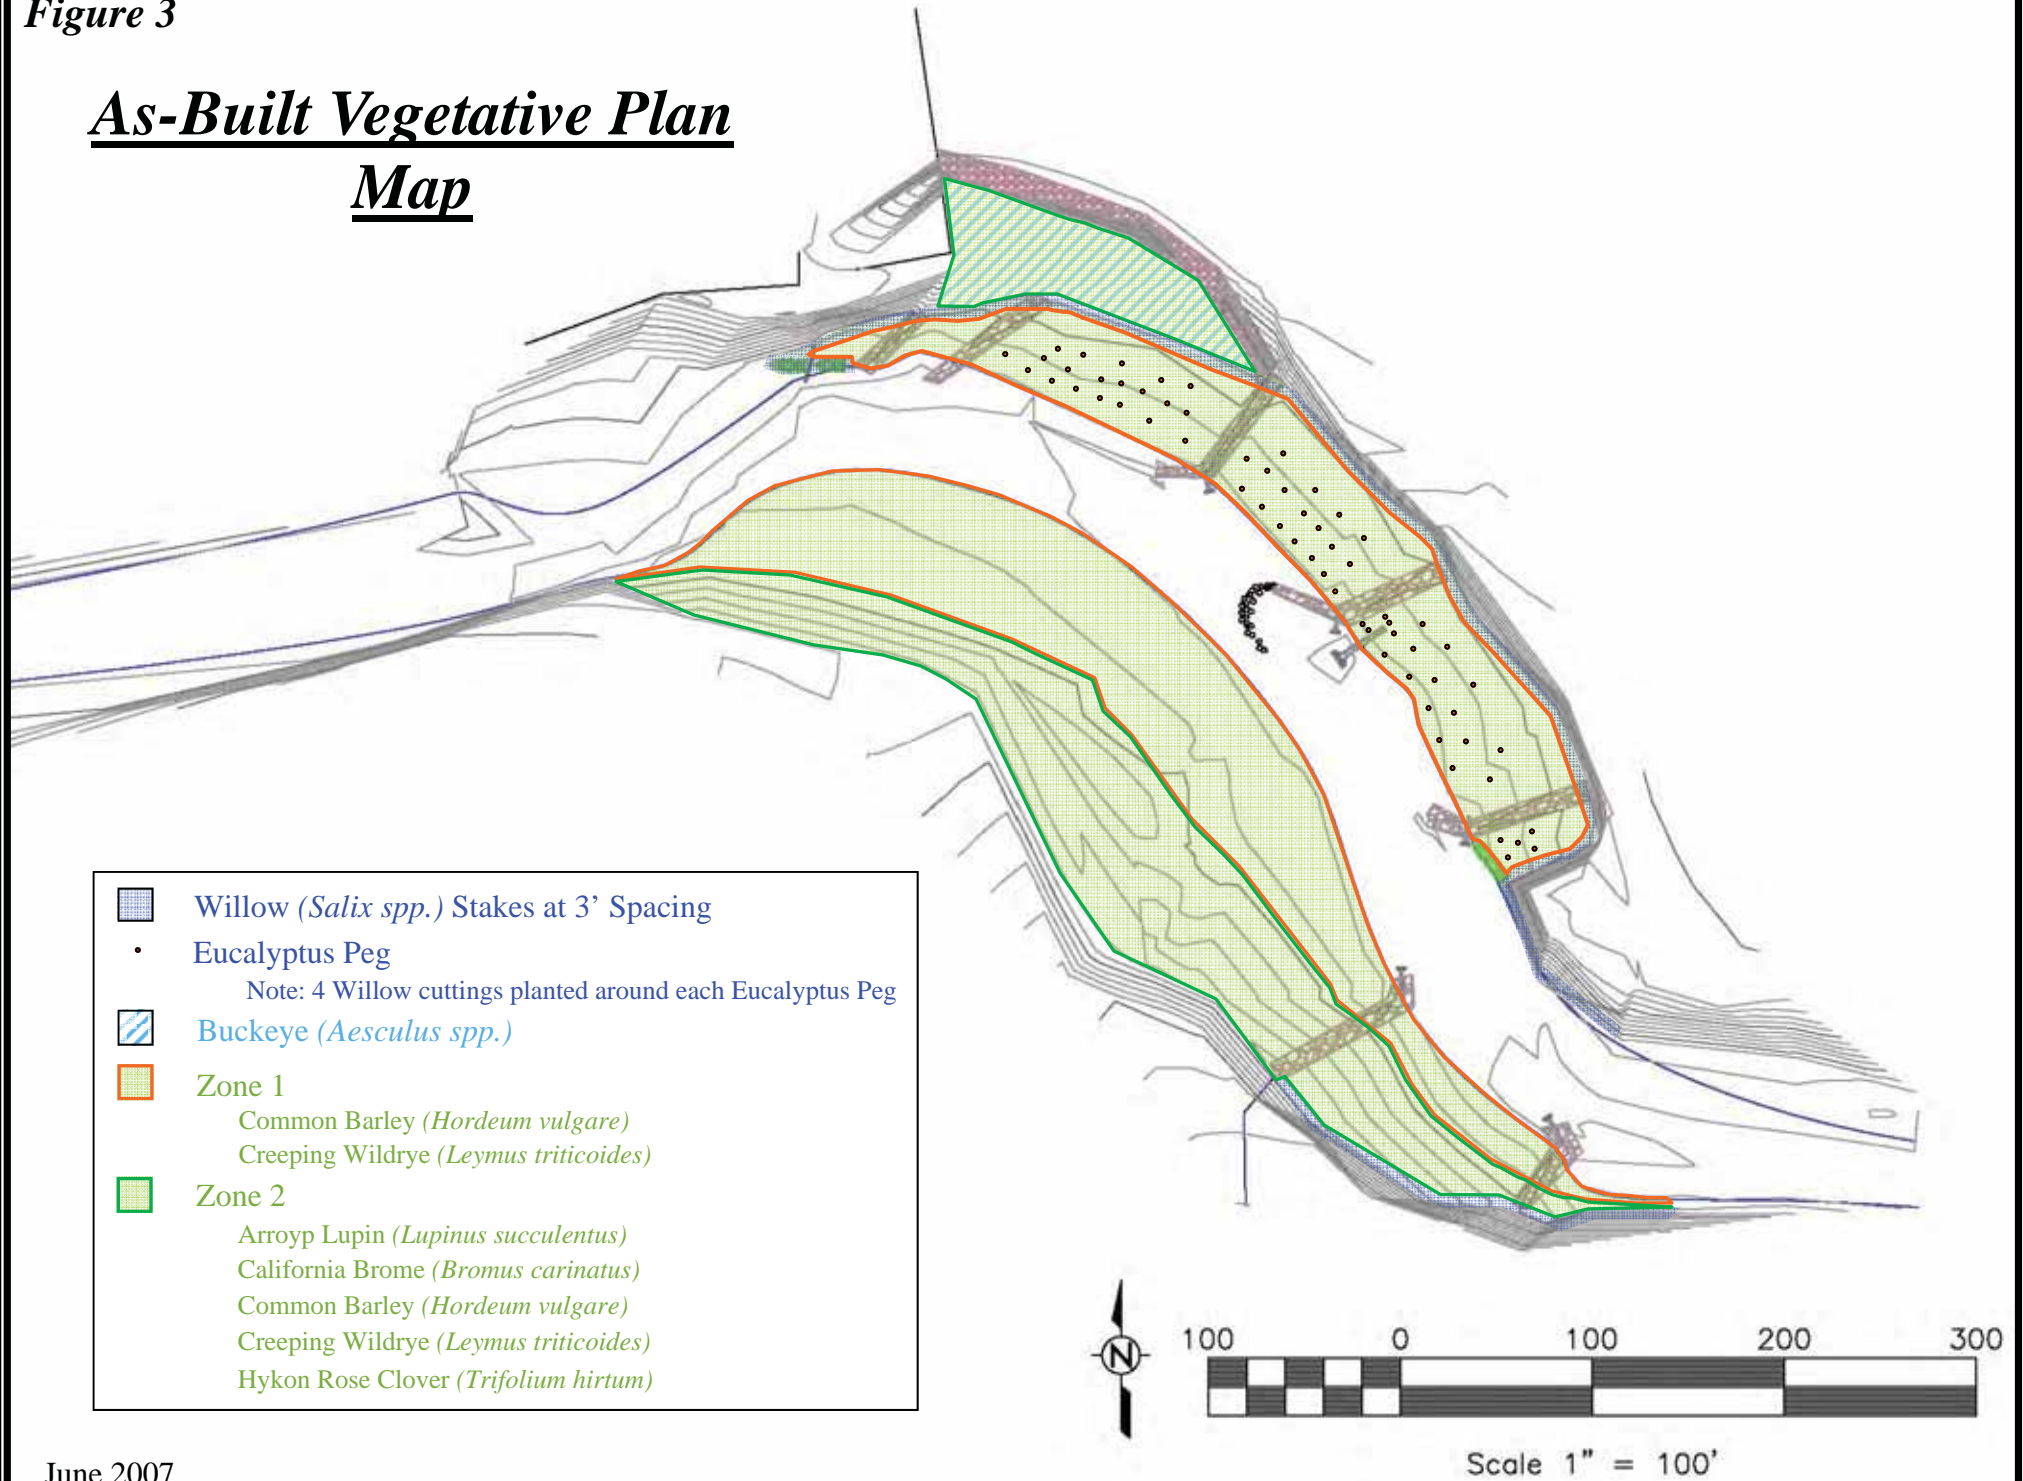
Figure 3

The “As Built” Vegetation Map (Figure 3) shows the vegetation plantings as of June 2007 including type, number and locations. In addition, over 100 willow stakes were installed in November 2007 to further enhance the site and replace stakes lost during the year. These stakes were installed in Zone 1, mostly along the Rock Barbs and the channel edge. More willows and other species were planted in winter 2010/2011. Appendix B presents the As-Built planting plan.

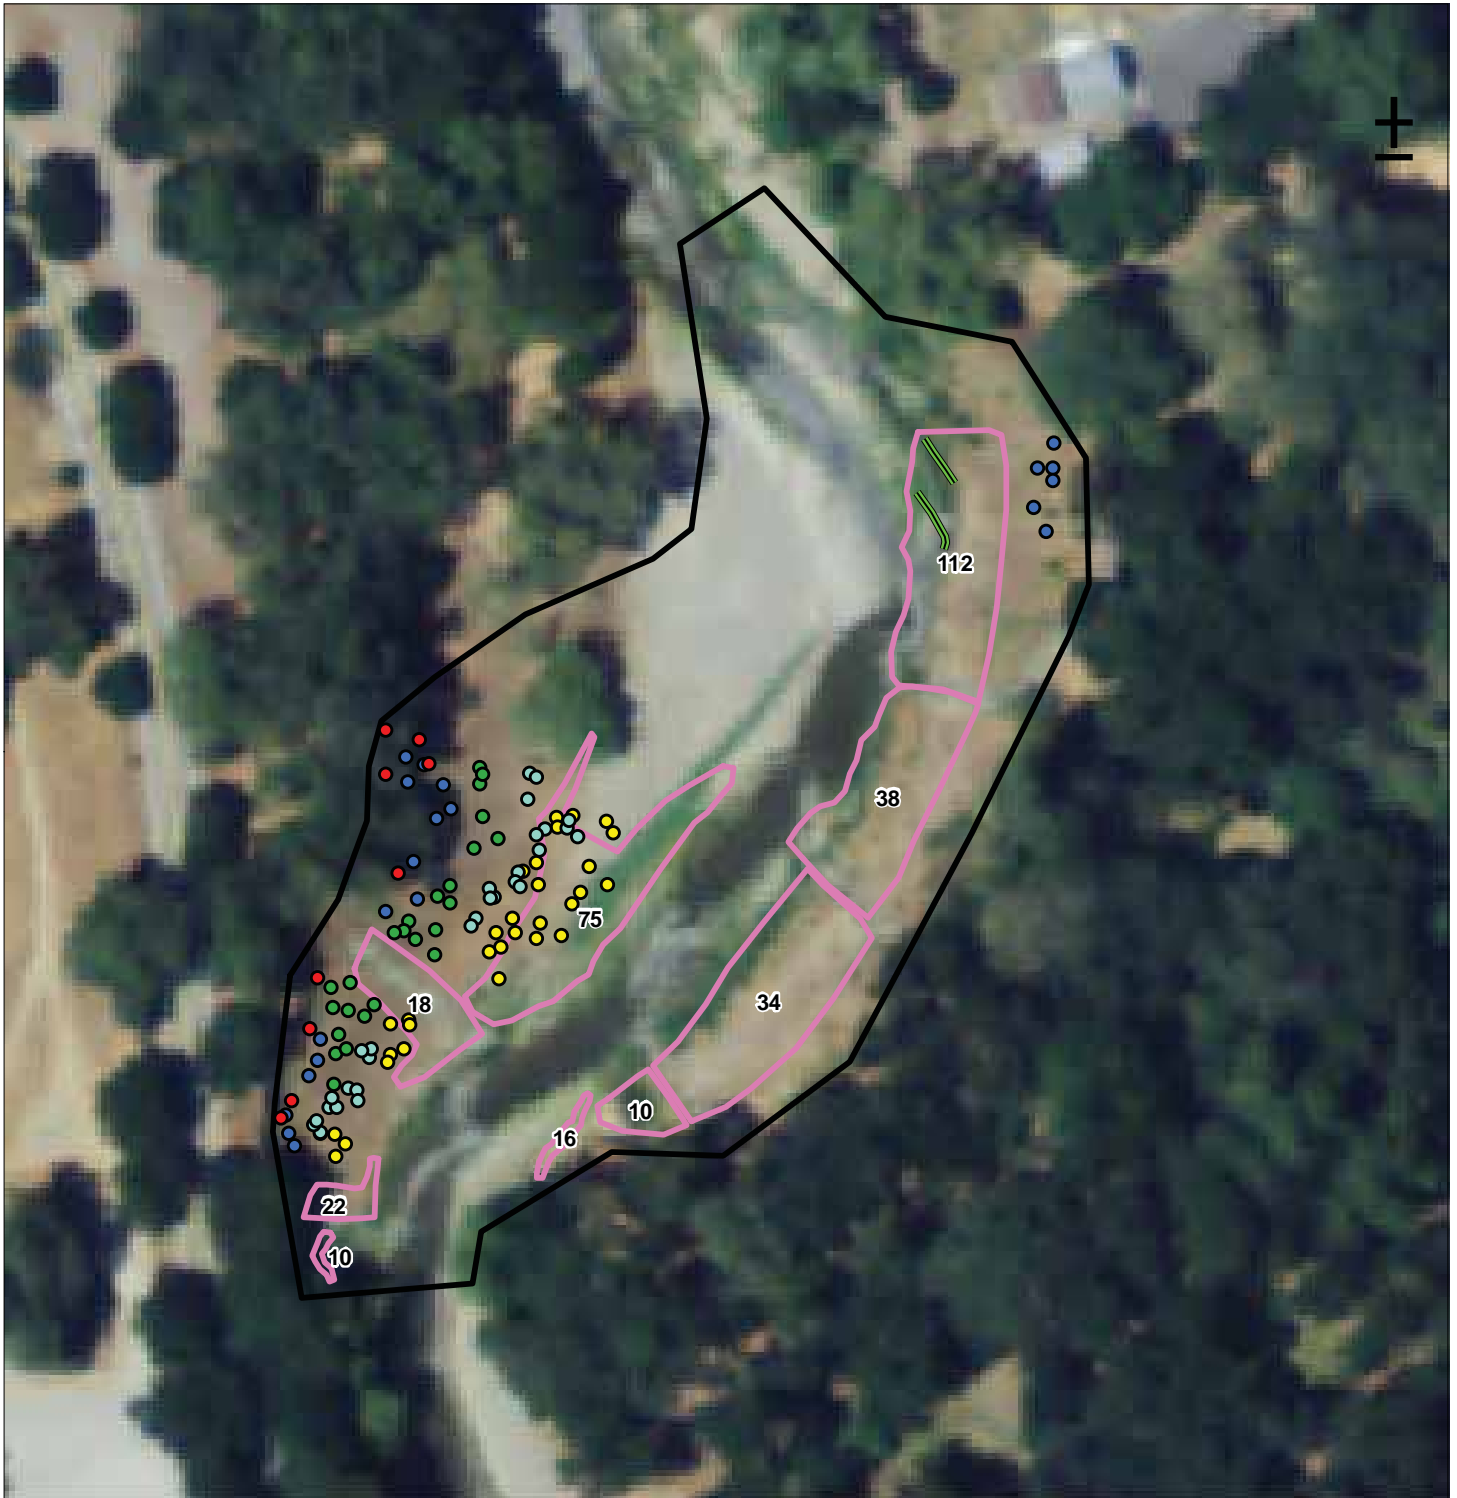
As-Built Planting Plan 2010/2011

As part of a SFPUC mitigation project, elderberry, buckeye, and coyote brush were planted in Zone 2 in winter 2010/2011 to enhance woody species cover for this area. Several non-native tree tobacco were removed from the banks in winter 2010/11. A few more individuals this species were observed during the monitoring event and will be removed in winter 2011/2012. Willow stakes in Zone 2 and along the toe of the slopes have not survived well in most of the project (less than 20%) as many were installed too high on the terraces to survive the drought years. In winter 2010/2011, additional willow stakes were installed with an irrigation system in order to establish willows in Zone 2.
