2010/2011 Annual Monitoring Report

Arroyo De La Laguna
Alameda County, California

U.S. Army Corps of Engineers File Number: 30262S
California Department of Fish and Game Notification Number: 0600-2006-0272-3
Regional Water Quality Control Board Site No.: 02-01-C0903

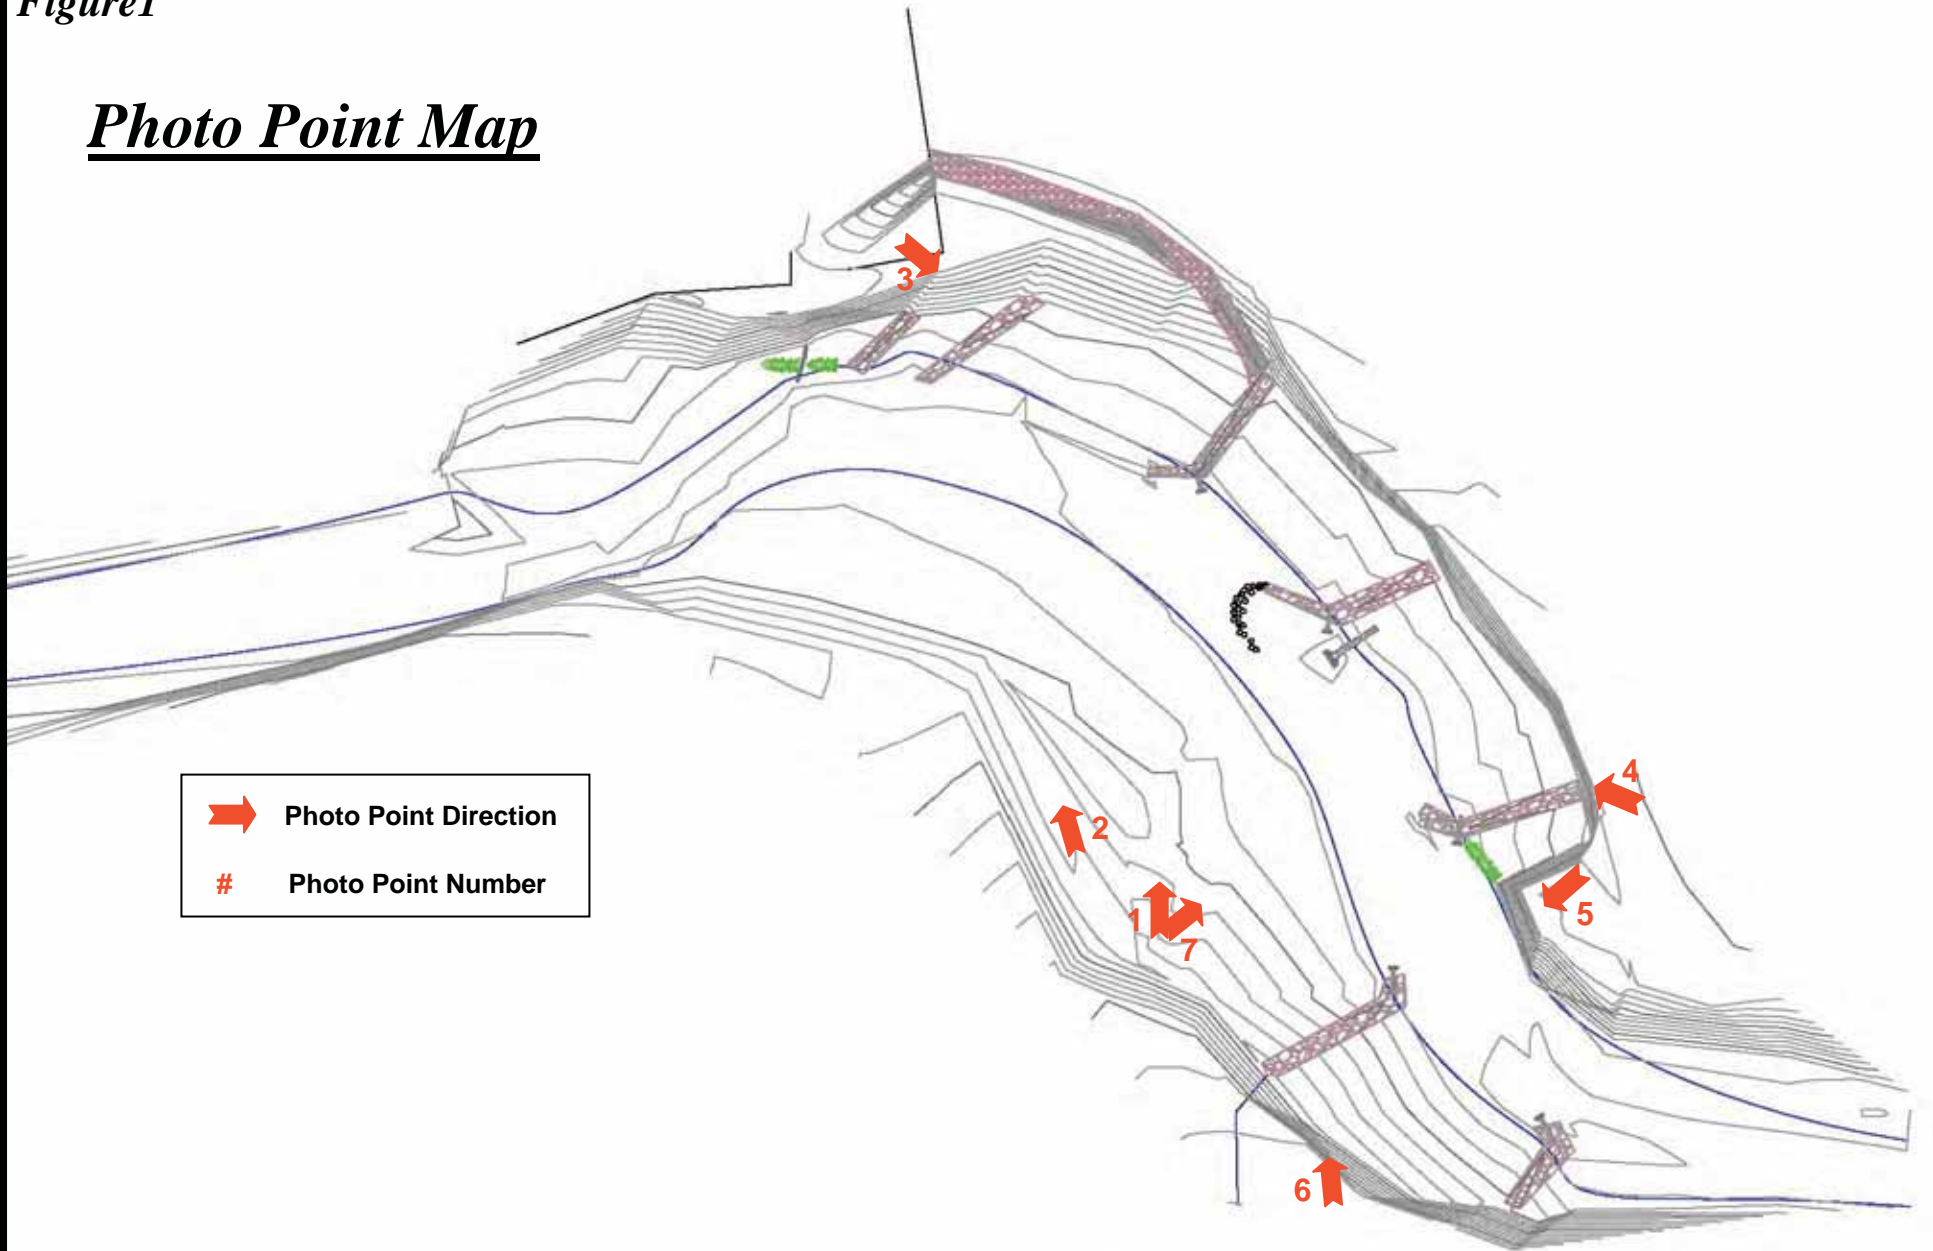
Figure 1 shows a map of the permanent photo points and directions. The photographs from this monitoring period are included in Appendix A. Each photo is labeled with location point or feature name, purpose of photo, and date. Pre-Project photographs from the photo points are also included for comparison.
